A River Saved!

Advanced Phyco-remediation of
Wastewater Drain – Punjab India

Executive Summary

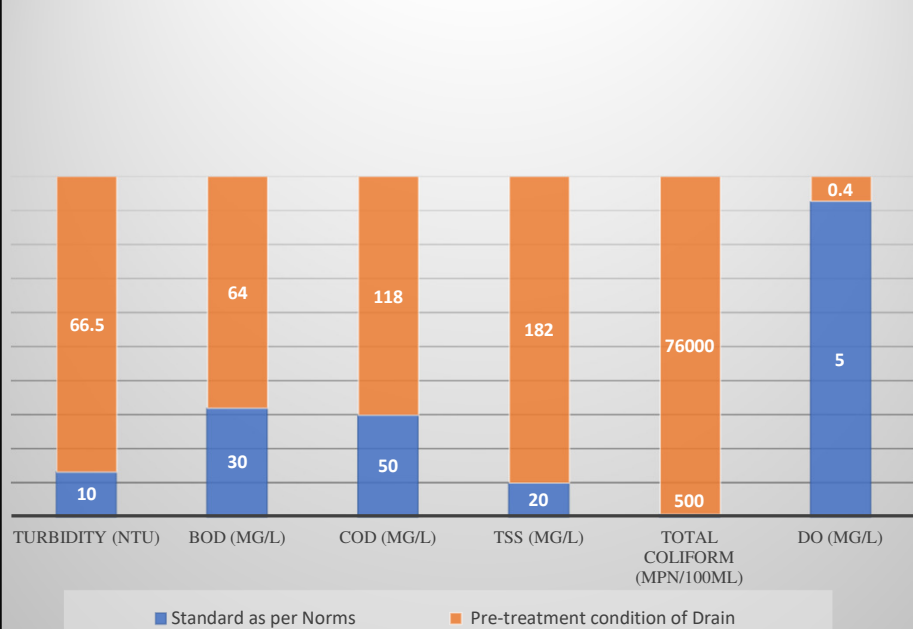
Pre-Treatment Parameters of Drain w.r.t. Norms

As per the client specified lab (NABL) pre-treatment analysis revealed several key parameters exceeding the permissible limits, including Biochemical Oxygen Demand (BOD) at 64 mg/l, Chemical Oxygen Demand (COD) at 118 mg/l, Total Suspended Solids (TSS) at 182 mg/l, Turbidity at 66.5 NTU, and Phosphate (P) at 5.6 mg/l. Dissolved Oxygen (DO) level was recorded at an alarmingly low 0.4 mg/l.

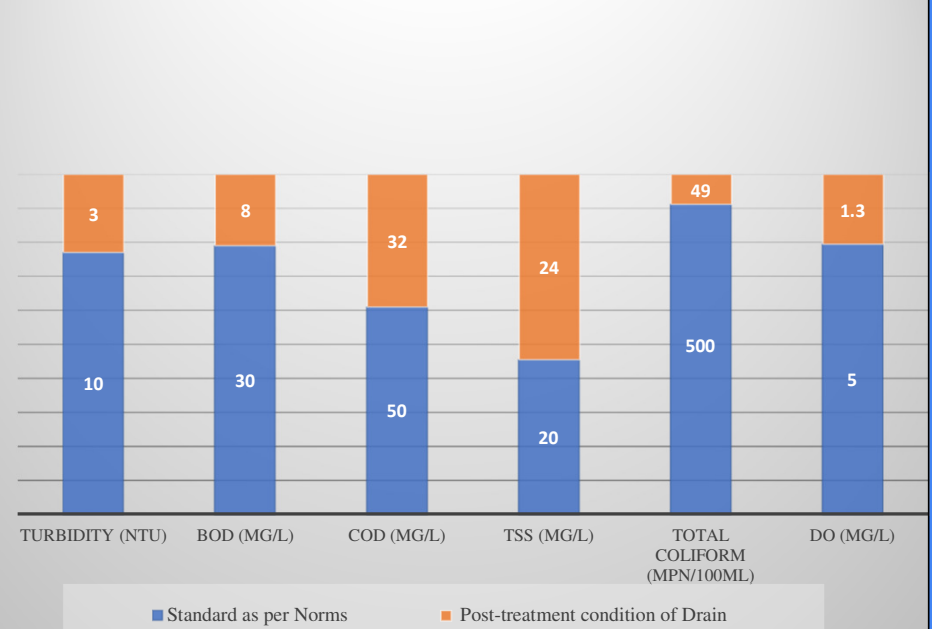
Post-Treatment Parameters of Drain w.r.t. Norms

Through Aquaritin intervention, significant improvements were achieved during the 30-day trial. BOD was reduced by 87%, TSS by 86%, Total Coliform by 99.9%, Ammonia, TKN, and TP by 70%, 76%, and 93% respectively. Biodegradation of settled sludge was also achieved, reducing the entire channel by 4.5 cm.
