Interim Report

AquaBioSolution® Treatment for IWK STP

Duration: 1st June 2022 until 31st August 2022
Alternative solution to reduce electricity, cost of maintenance and operation of sewage treatment plant through reduction in aeration pump usage.

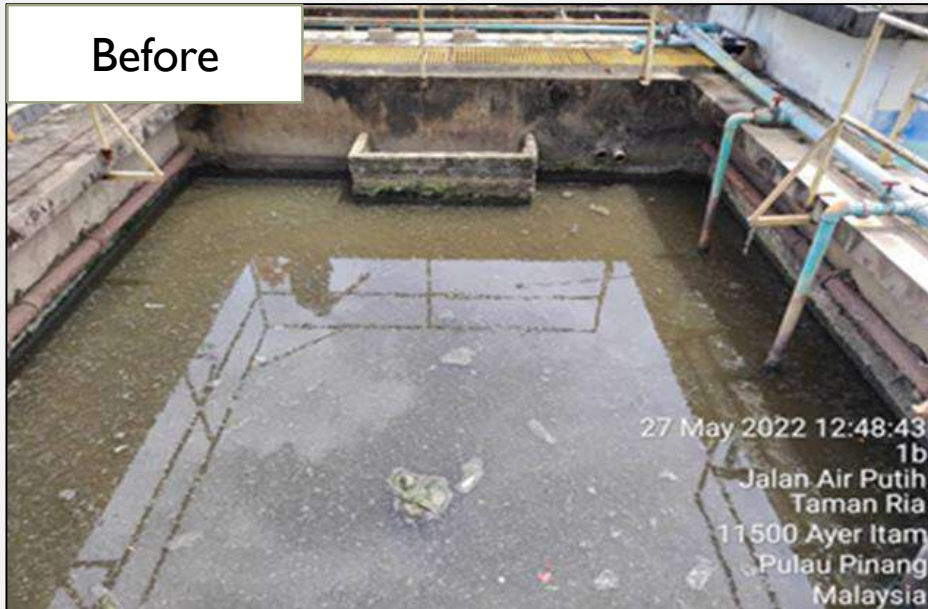
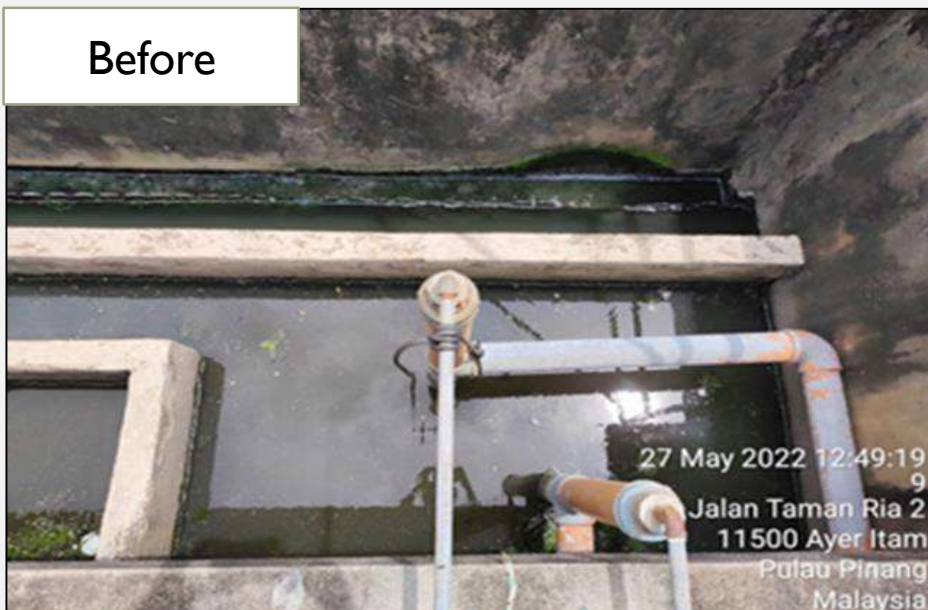
- Floating solids can be seen on surfaces of Aeration Tank.
- Foul odour.
- Activated sludge remained still on floor of Clarifier Tank.
- Aeration pump ran a total of 15 hours daily.

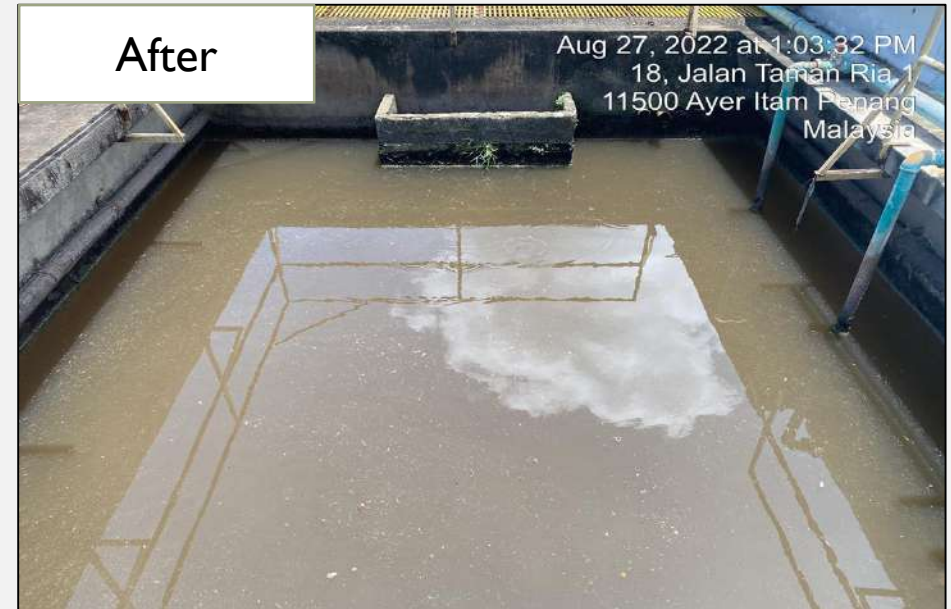
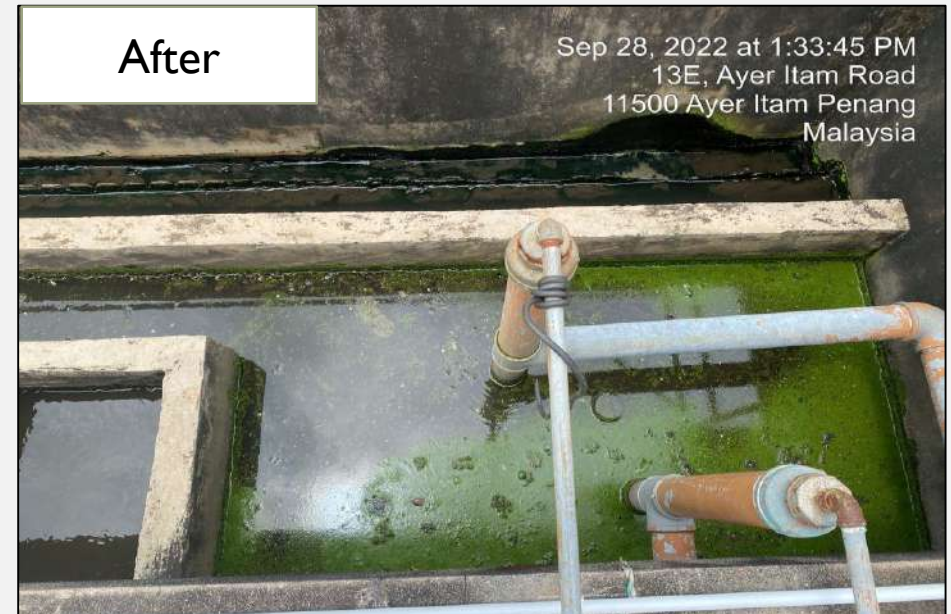
- Significant reduction in floating solids on Aeration Tank.
- No foul odour.
- Surfaces of Aeration Tank highly reflective.
- Activated sludge was successfully disintegrated via microbial activities, releasing trapped nutrient.
- Aeration pump was reduced to 3 hours daily (80% reduction).
- Final Effluent remain compliance with DOE standards despite 80% in Aeration pump timer.

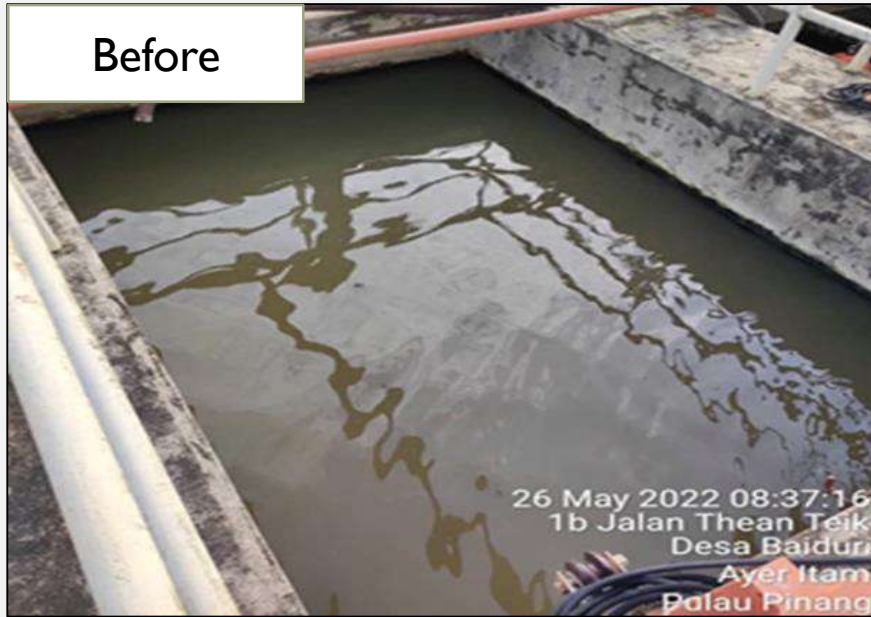
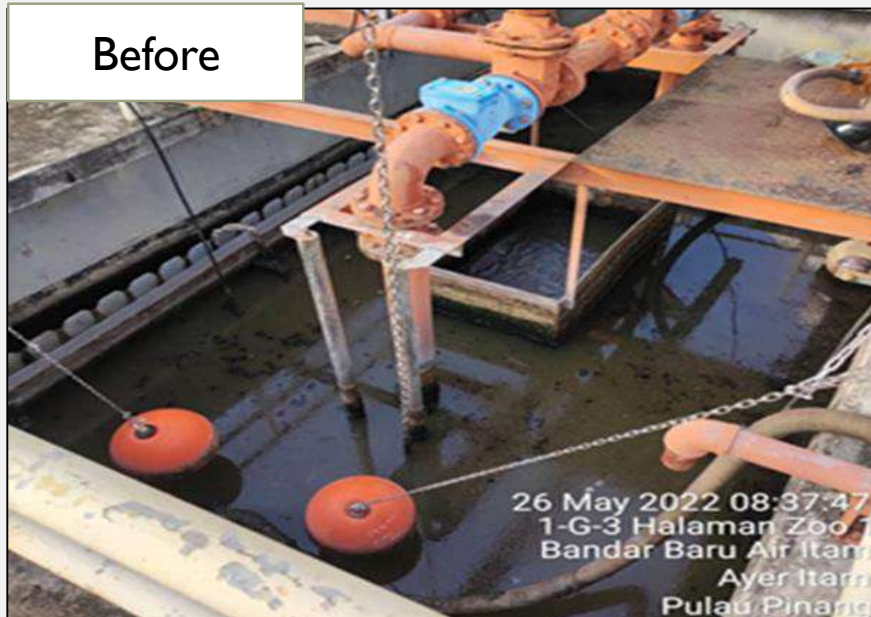
- Condition of Aeration Tank clear of floating solids.
- Clarifier Tank contains small amount of floating solids with dark water surface colour.
- Activated sludge remained still on floor of Clarifier Tank.
- Aeration pump ran a total of 20 hours daily.

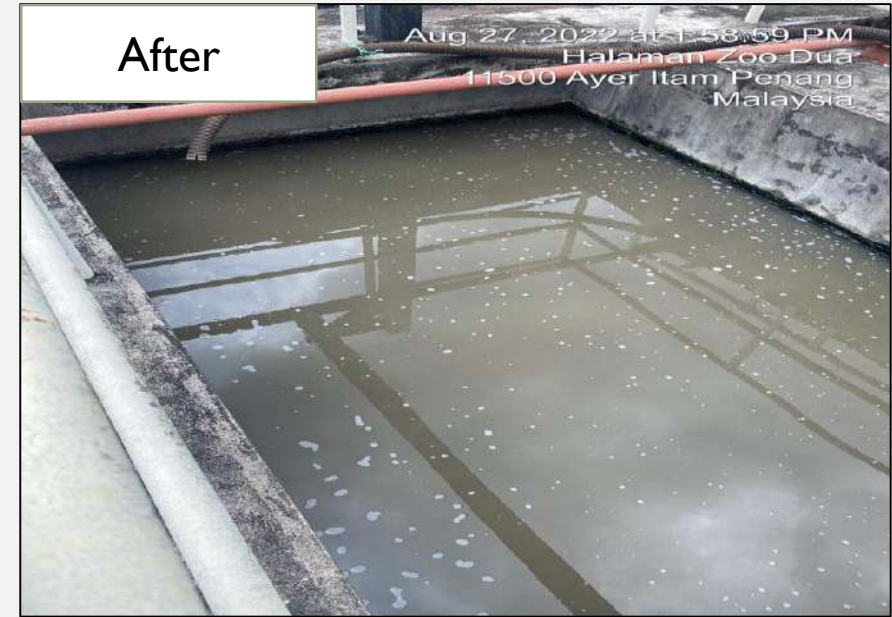
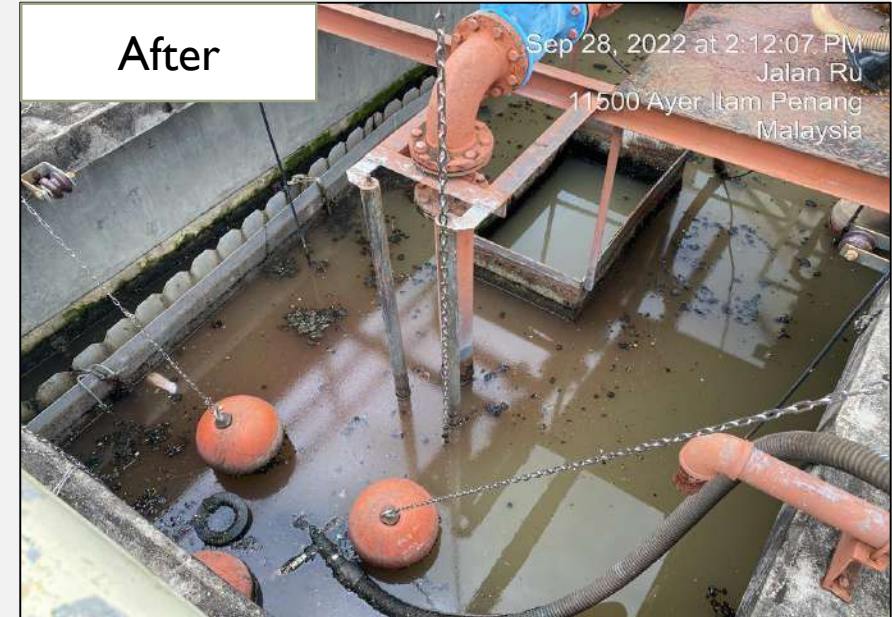
- Surface colour of Aeration Tank becomes brighter as compared to 3 months prior.
- Absence of foul odour was maintained.
- Surfaces of both Aeration & Clarifier Tank becomes highly reflective.
- Aeration pump was reduced to 4 hours daily (80% reduction).
- Final Effluent remain compliance with DOE standards despite 80% in Aeration pump timer.

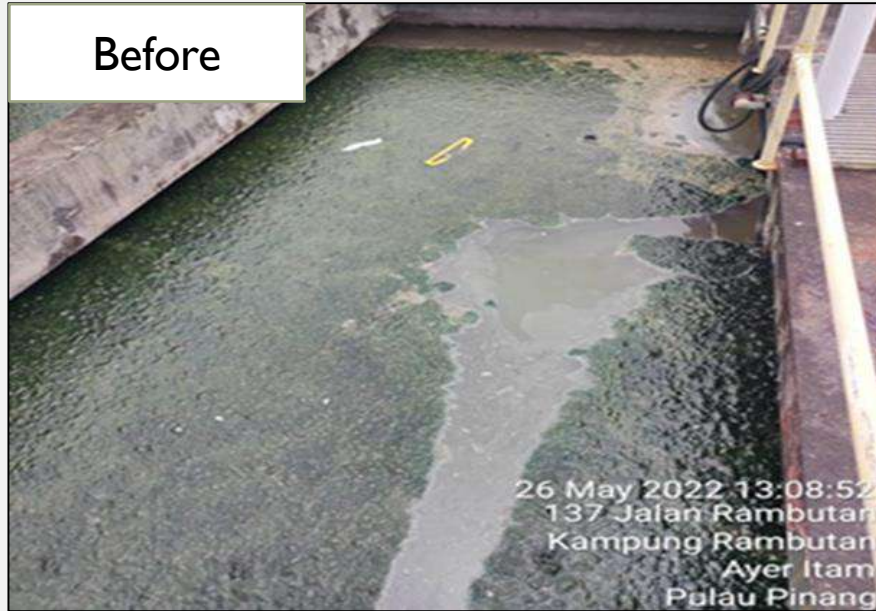
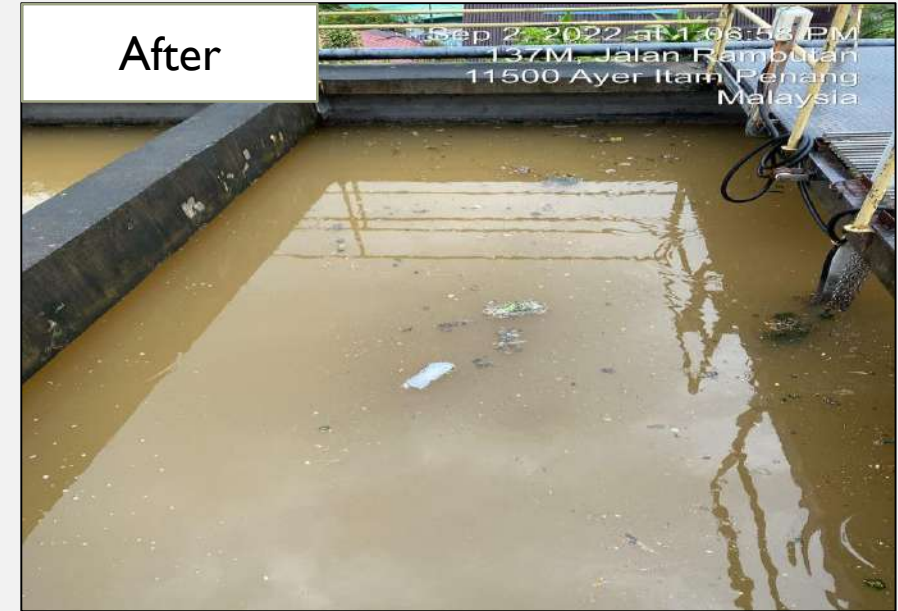
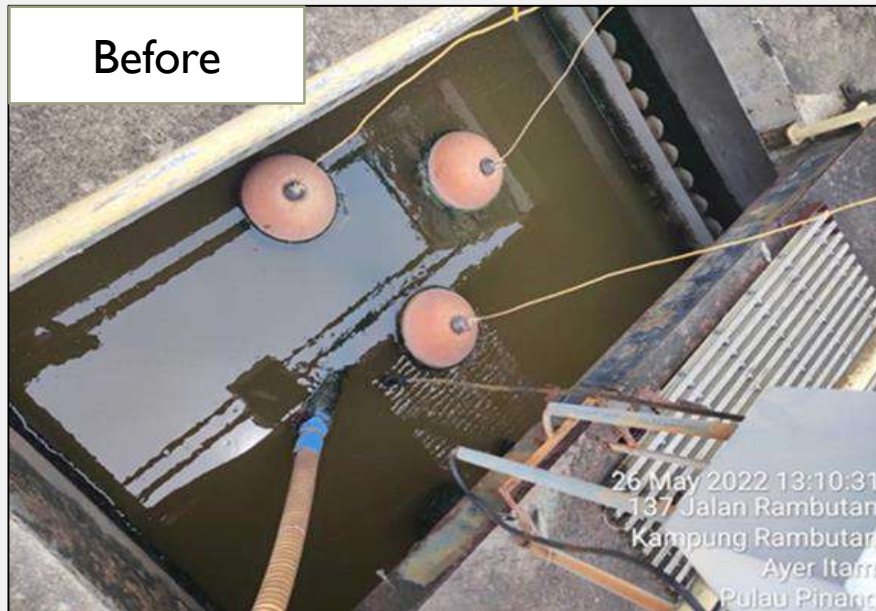
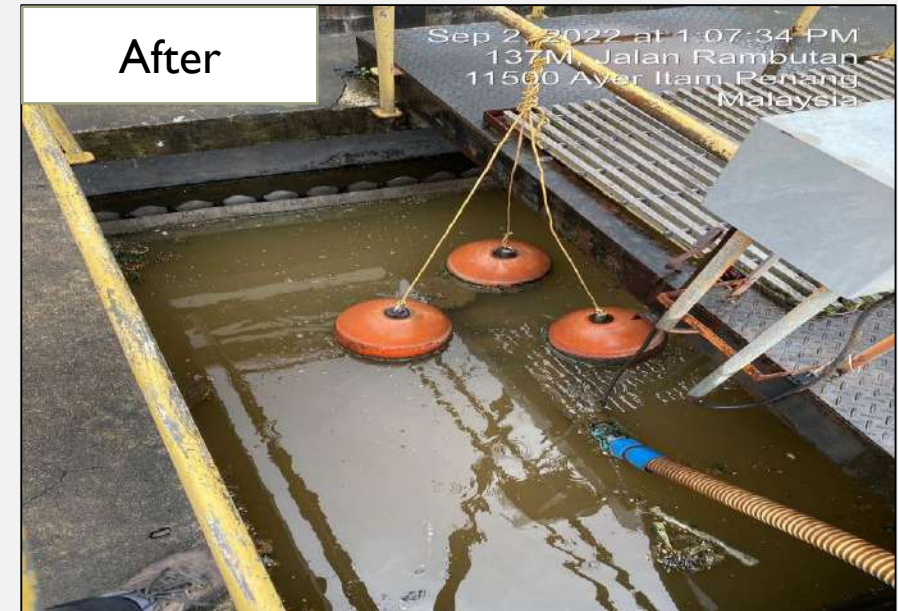
Aeration & Clarifier Tank (PEG 024 – TAMAN FAIRY HEIGHT)

- Surface of Aeration Tank was covered with green algae film.
- Pungent odour at Aeration Tank.
- Aeration pump ran a total of 15 hours daily.

- Green algae film on Aeration Tank was successfully eliminated, providing a clear surface appearance.
- Pungent odour was eliminated.
- Aeration pump was reduced to 3 hours daily (80% reduction).
- Final Effluent remain compliance with DOE standards despite 80% in Aeration pump timer.

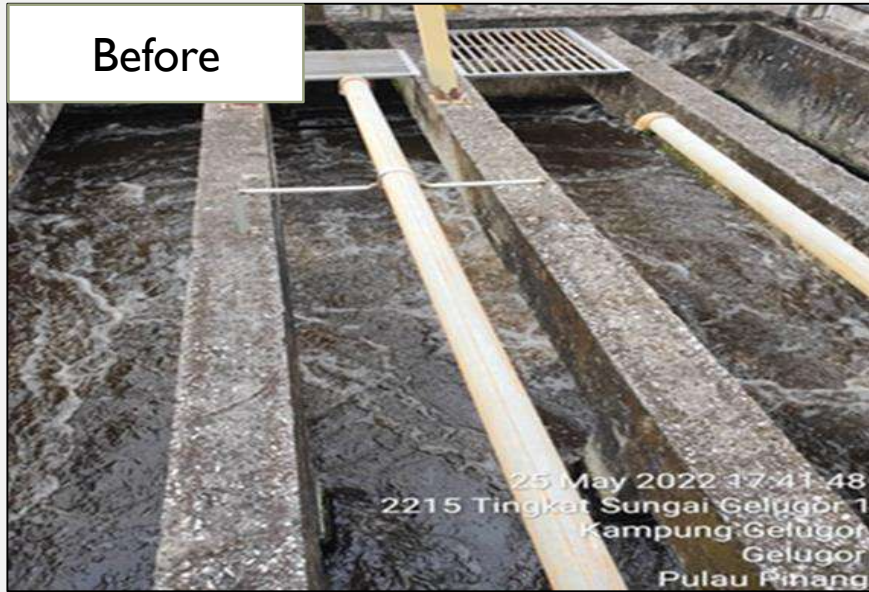
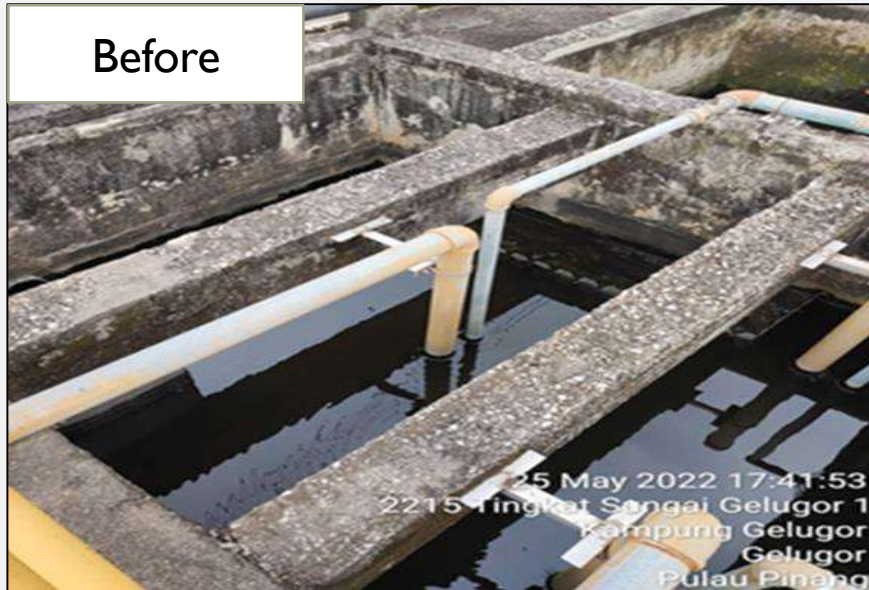
- No foul odour at Aeration Tank
- Aeration & Clarifier Tank water colour slightly dark.
- Aeration pump ran a total of 16 hours daily.

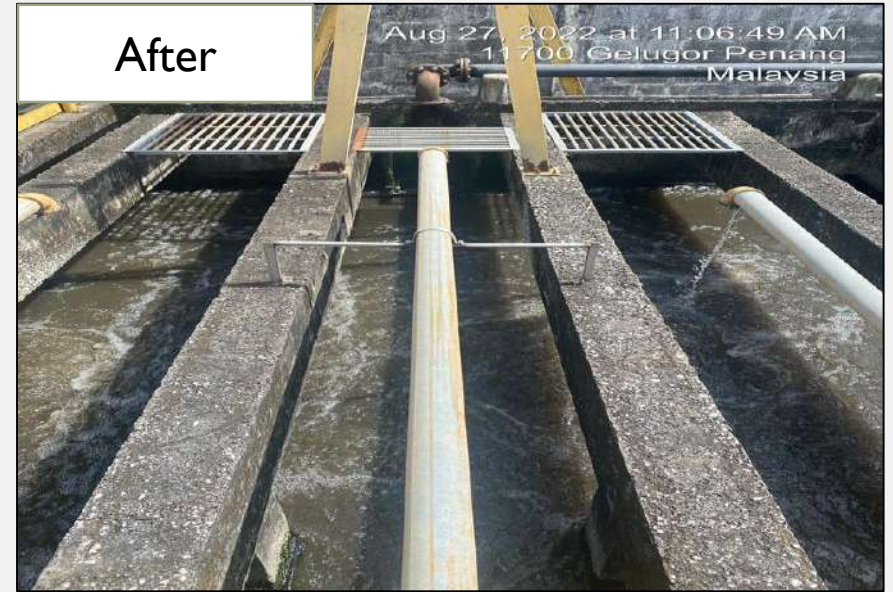
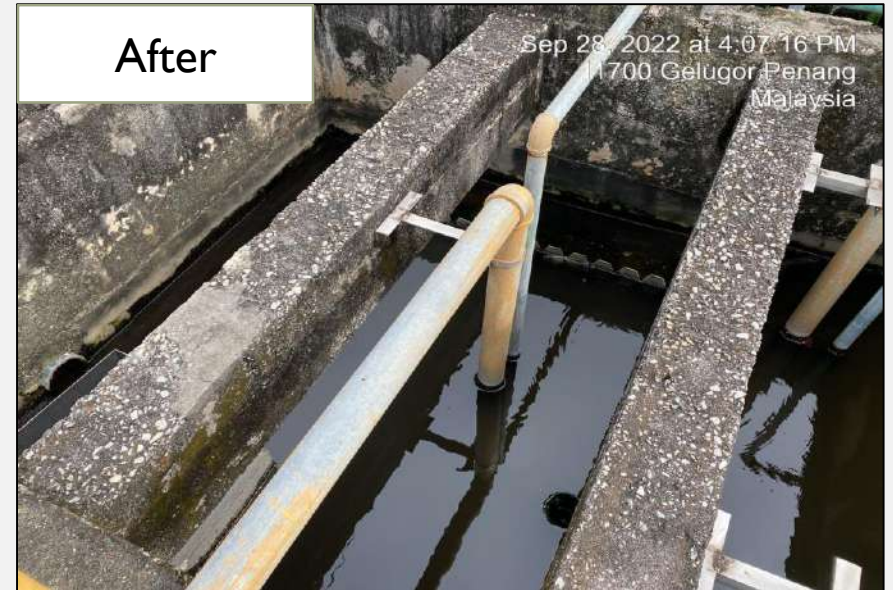
- Surface colour of Aeration & Clarifier Tank becomes brighter as compared to 3 months prior.
- Absence of foul odour was maintained.
- Aeration pump was reduced to 3.2 hours daily (80% reduction).
- Final Effluent remain compliance with DOE standards despite 80% in Aeration pump timer.

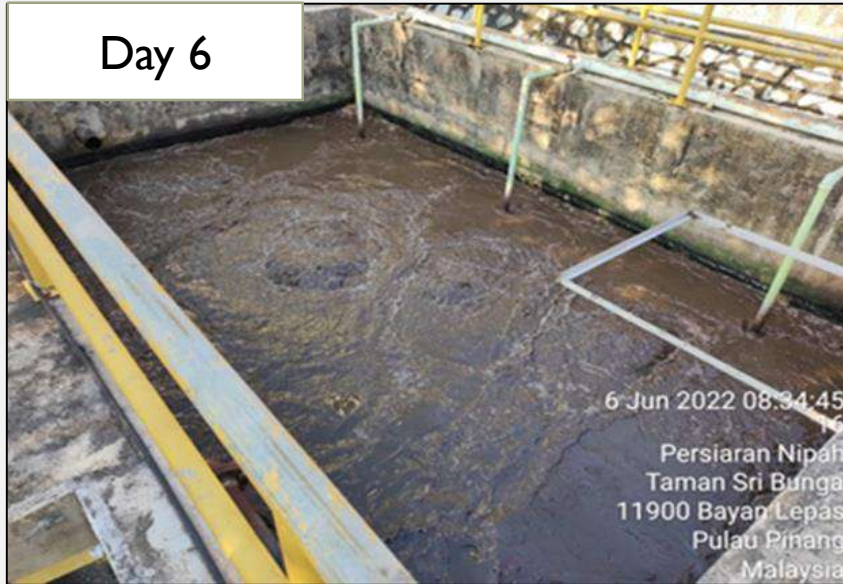
After

Aeration & Clarifier Tank (PEG 060 – PERSIARAN NIPAH)

- Aeration Tank water surface condition becomes brighter after 3 months of enhance phycoremediation & bioremediation treatment.
- Absence of foul odour was maintained.
- Surfaces of both Aeration becomes highly reflective.
- Aeration pump was reduced to 3.2 hours daily (80% reduction).
- Final Effluent remain compliance with DOE standards despite 80% in Aeration pump timer.

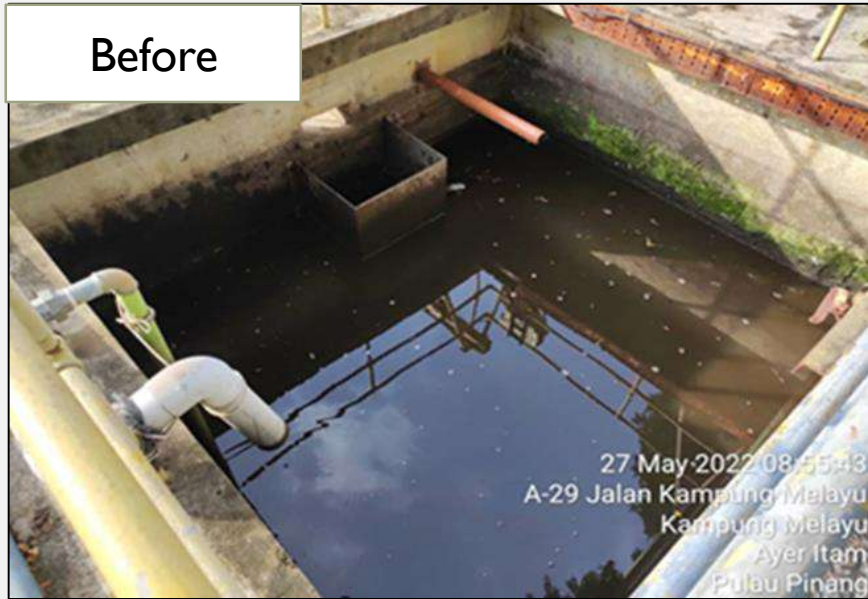
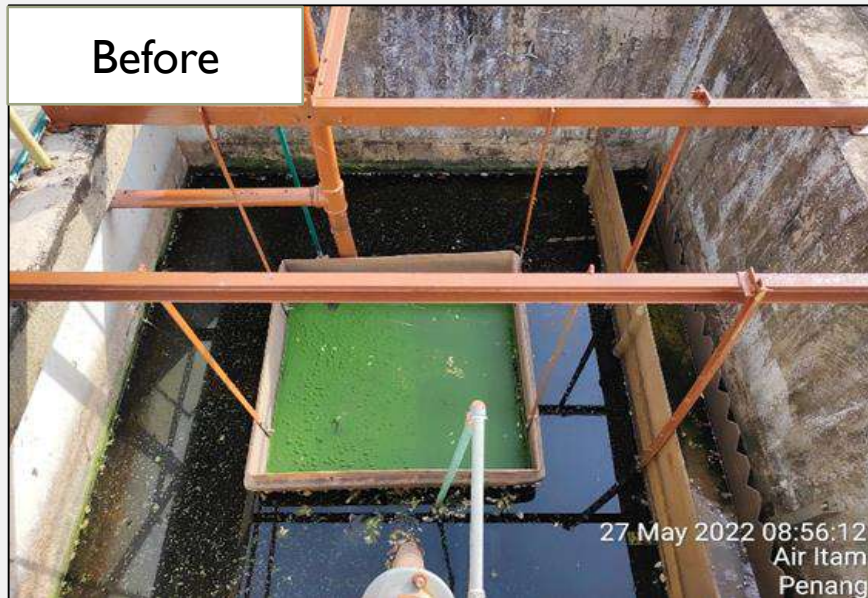
- Colour of Aeration Tank is dark brown.
- No foul odour was recorded.
- Aeration pump ran a total of 15 hours daily.

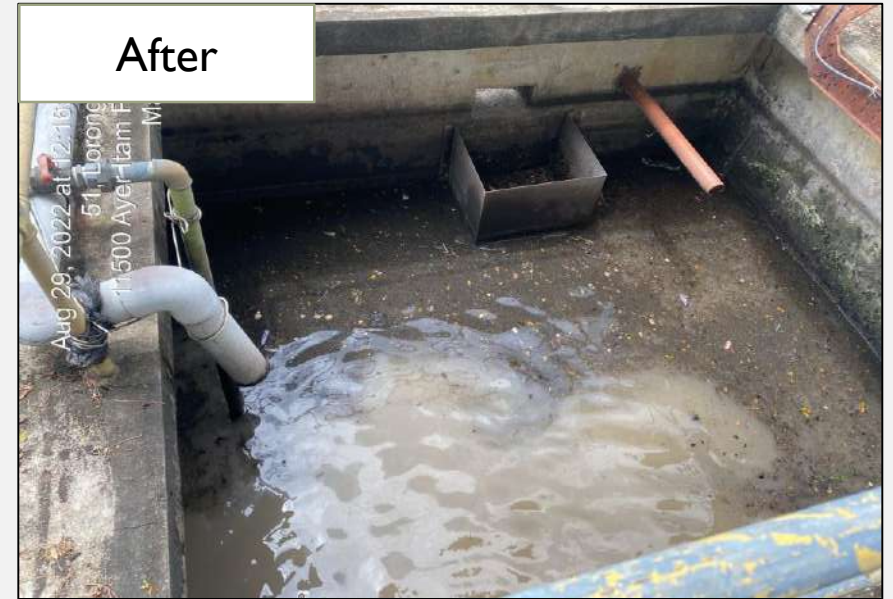
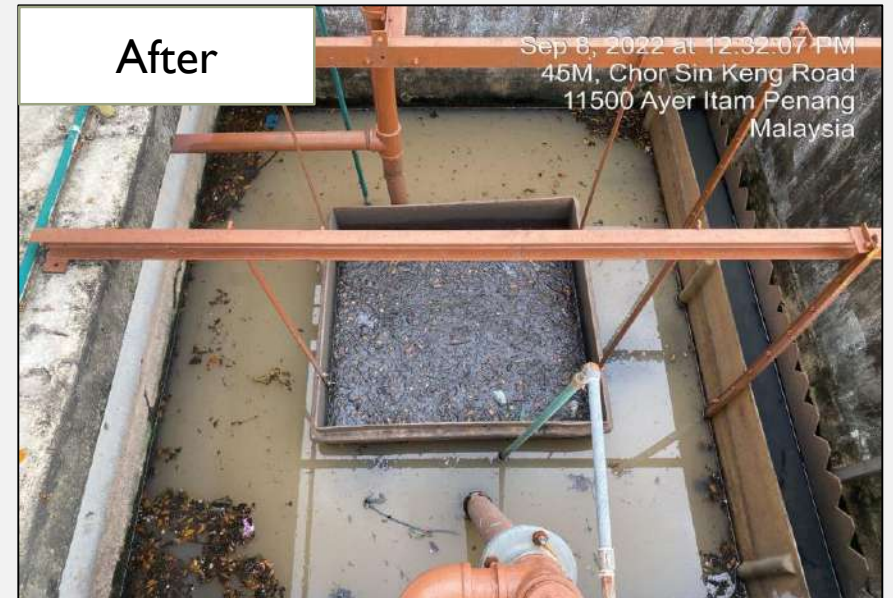
- Aeration Tank water colour becomes brighter after 3 months of treatment.
- Absence of foul odour was maintained.
- Activated sludge was successfully disintegrated via microbial activities, releasing trapped nutrient & sludges, causing sludges to rise on surface of tank.
- Aeration pump was reduced to 3 hours daily (80% reduction).
- Final Effluent remain compliance with DOE standards despite 80% in Aeration pump timer.

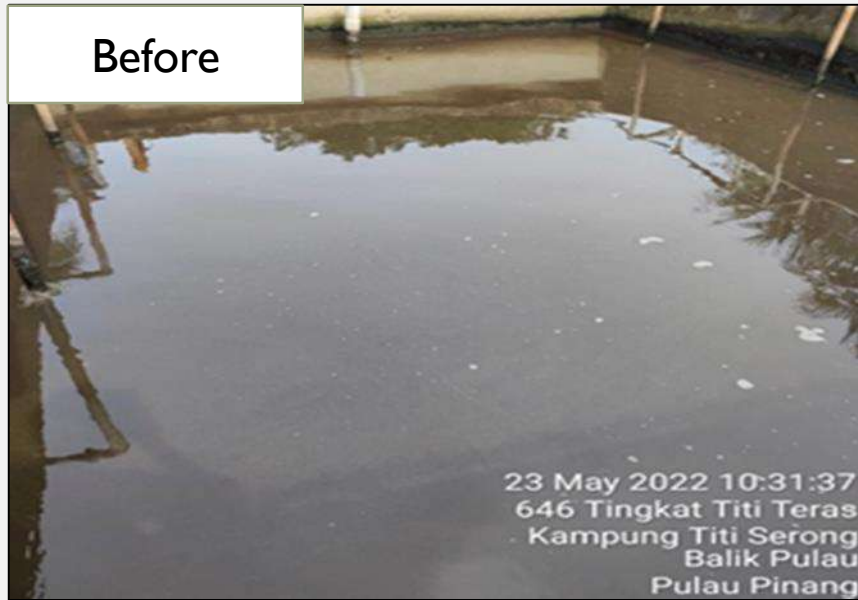
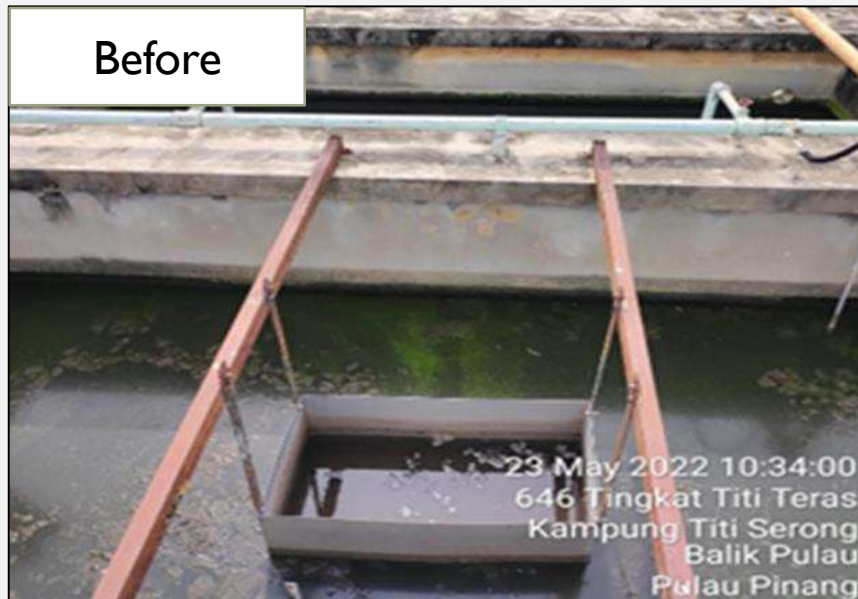
- Colour of Aeration Tank is dark brown.
- Slightly pungent odour was detected near Aeration Tank.
- Clarity of Aeration Tank is low.
- Aeration pump ran a total of 12 hours daily.

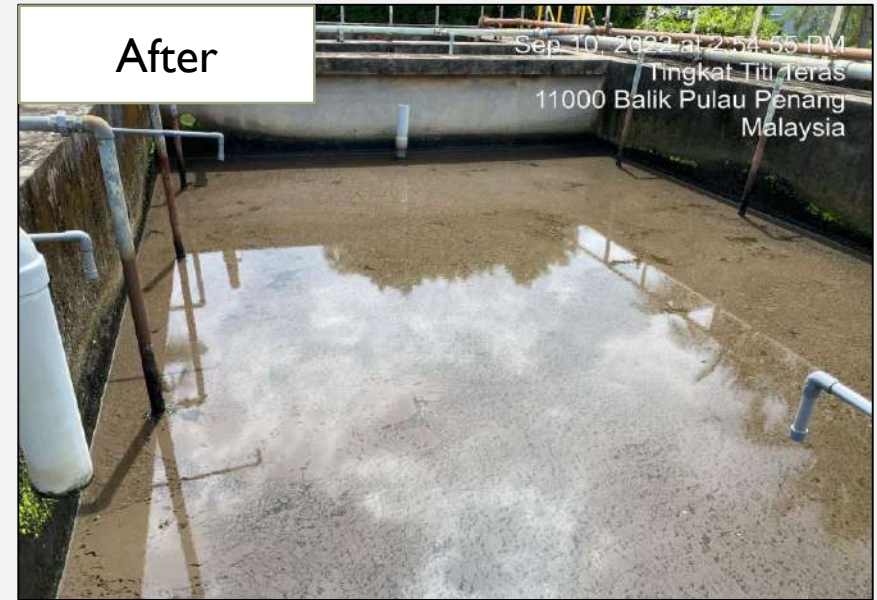
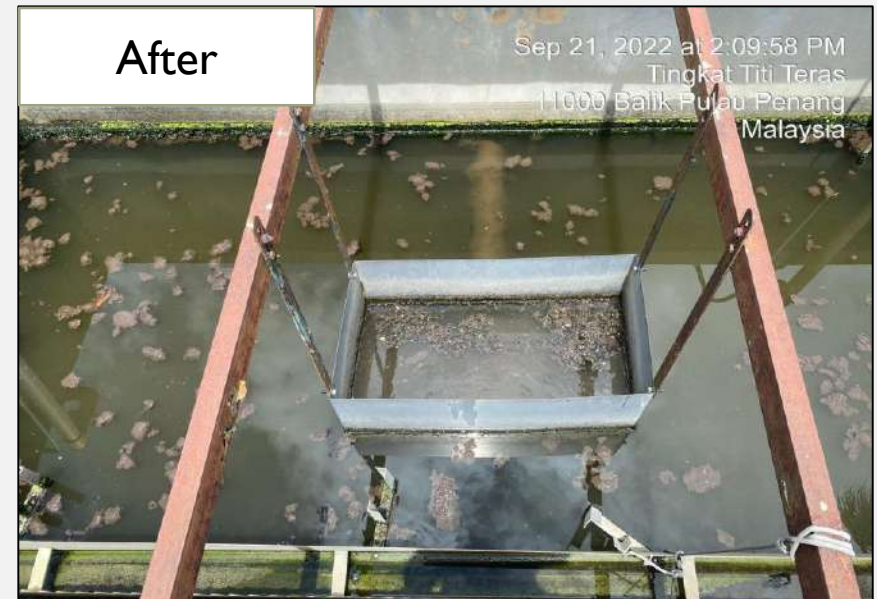
- Colour of Aeration Tank becomes brighter with a significant increase in reflectivity of water surface, indicating increase in population of Diatom contained in Aeration Tank.
- Activated sludge in Clarifier Tank was successfully disintegrated via microbial activities, releasing trapped nutrient & sludges, causing sludges to float on surface of tank.
- Aeration pump was reduced to 2.4 hours daily (80% reduction).
- Final Effluent remain compliance with DOE standards despite 80% in Aeration pump timer.

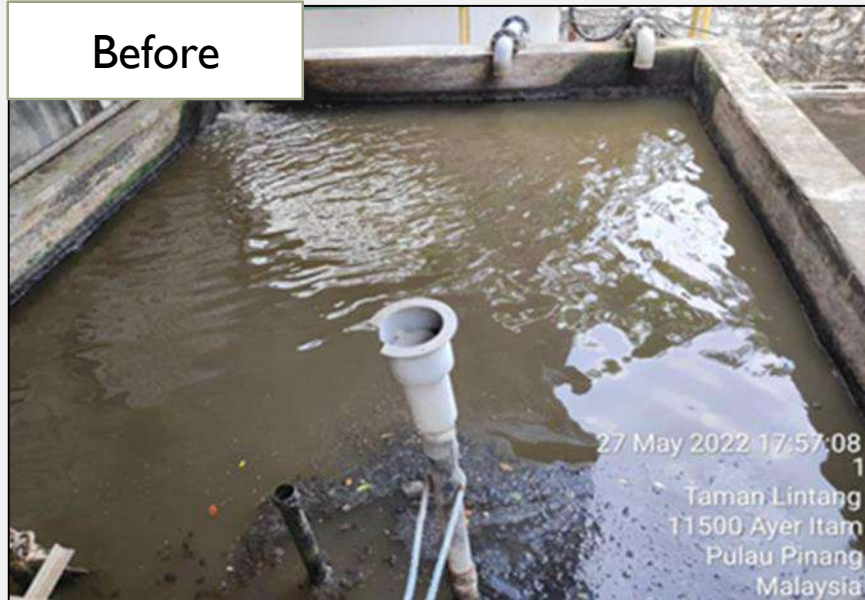
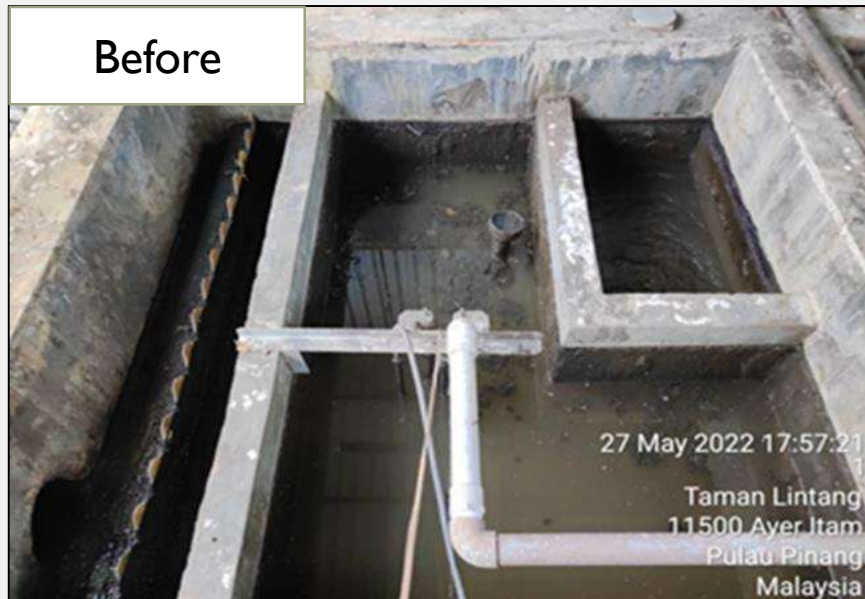
- Colour of Aeration Tank was dark brownish-yellow with small amount of floating solids on surface of water.
- Colour of Clarifier Tank was dark brown with some floating sludges on surface of tank.
- No foul odour was detected at Aeration Tank.
- Aeration pump ran a total of 20 hours daily.

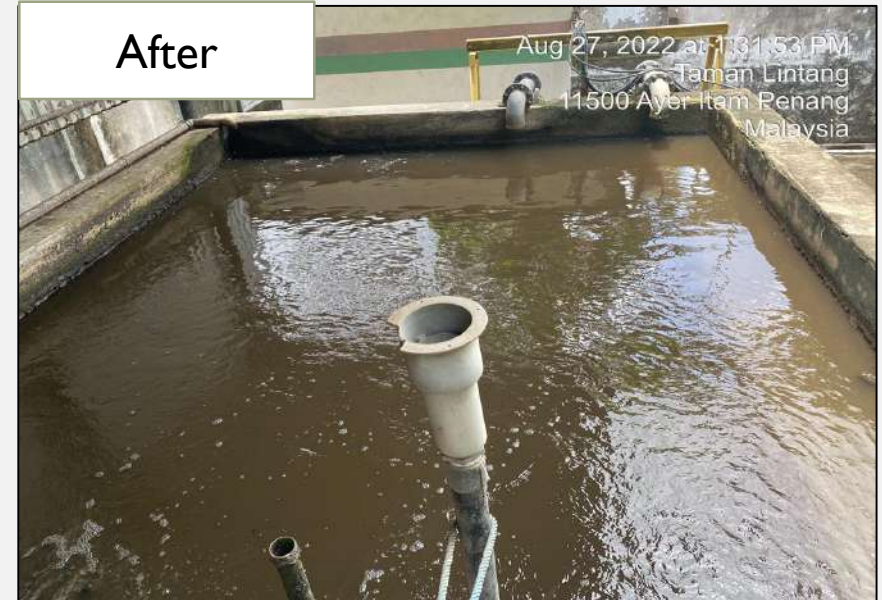
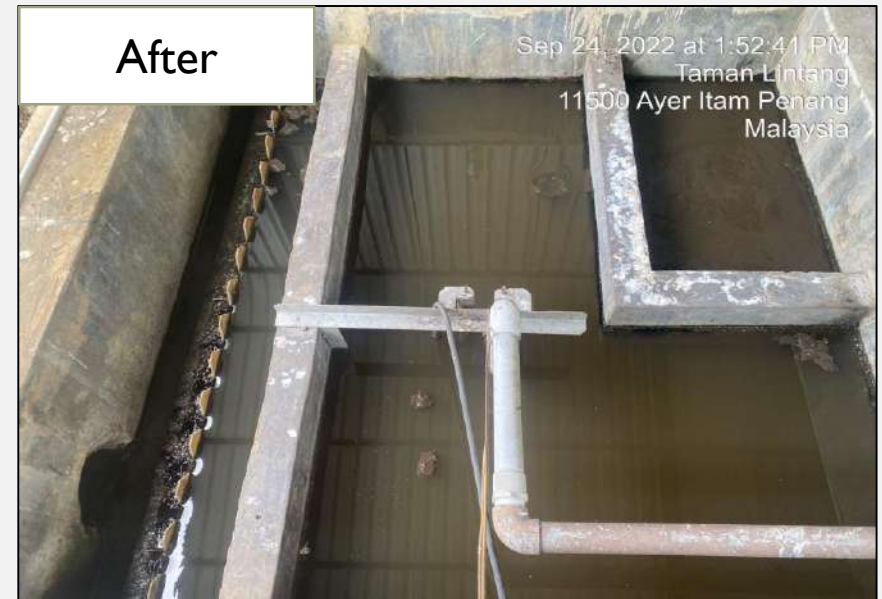
- Colour of both Aeration & Clarifier Tank becomes brighter brown as compared to pre-treatment condition.
- Absence of foul odour was maintained.
- Activated sludge in Clarifier Tank was successfully disintegrated via microbial activities, releasing trapped nutrient & sludges, causing a slight increase of sludges to float on surface of tank.
- Aeration pump was reduced to 4 hours daily (80% reduction).
- Final Effluent remain compliance with DOE standards despite 80% in Aeration pump timer.

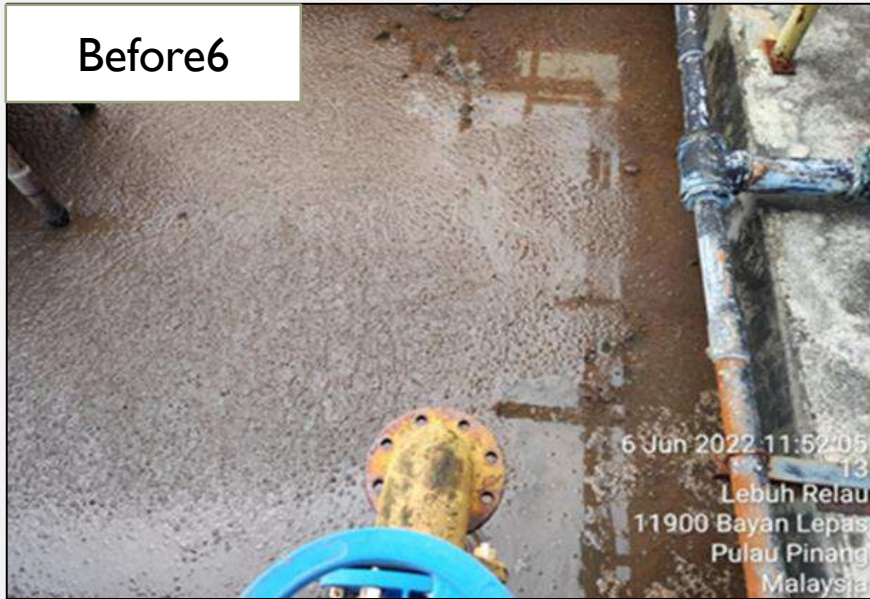
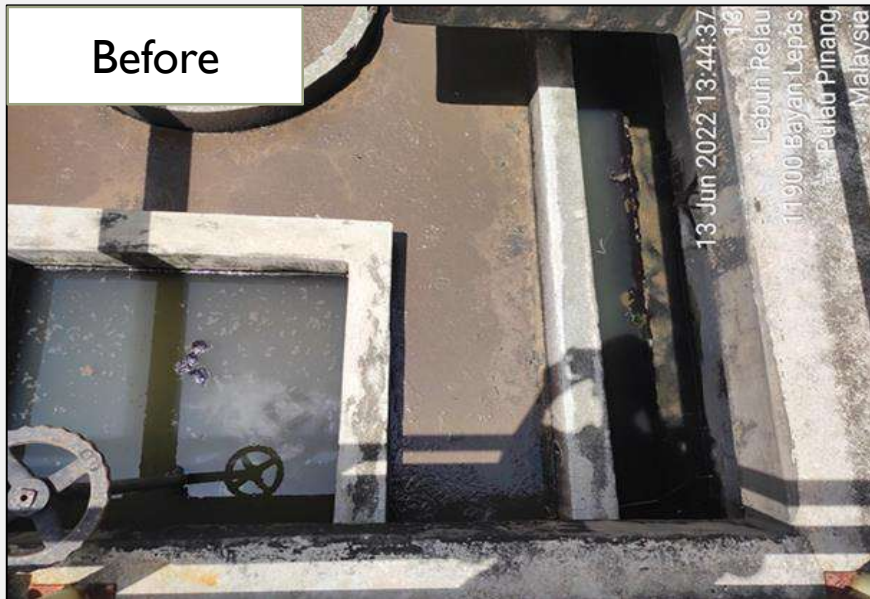
- Colour of Aeration Tank was bright brown with thick semi-hard layer of floating sludge covering surface of Aeration Tank.
- Slight foul odour was recorded at Aeration Tank.
- Thin fatty-brown film was observed on the surface of Clarifier Tank.
- Aeration pump ran a total of 14 hours daily.

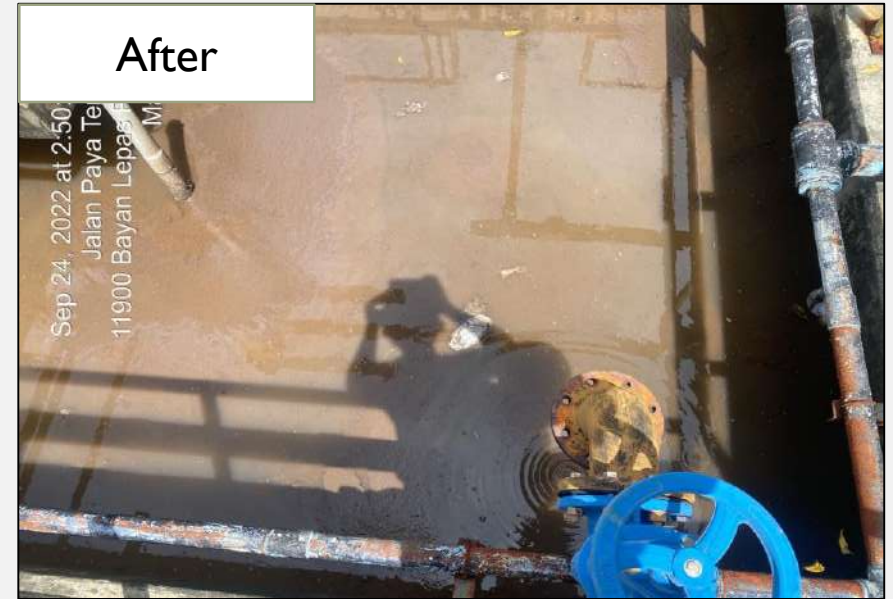
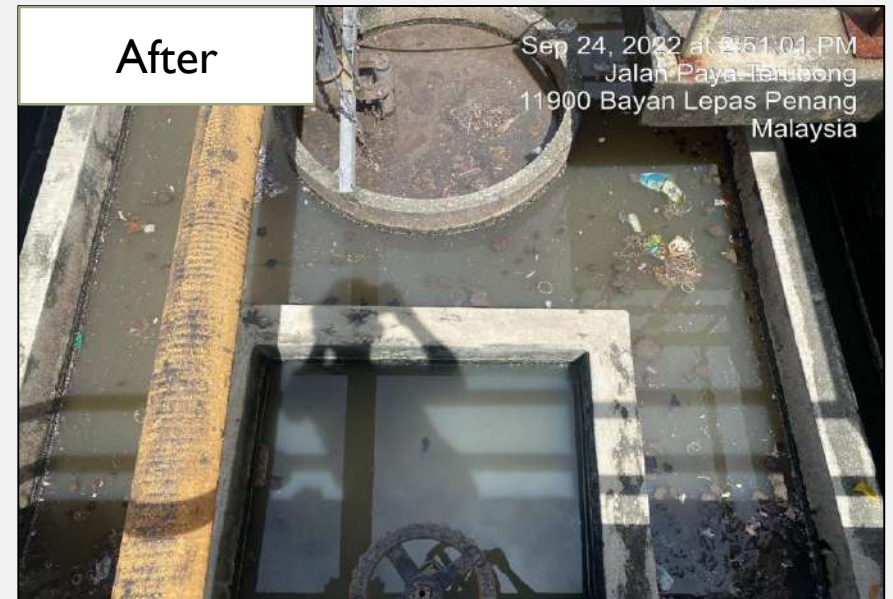
- Thick semi-hard layer of floating sludge was able to be broken down into a more liquid form after 3 months of treatment.
- Foul odour was able to be eliminated and maintained.
- Layers of floating sludge can be observed at Clarifier Tank due to activated sludge being disintegrated and released to surface of tank.
- Aeration pump was reduced to 2.8 hours daily (80% reduction).
- Final Effluent remain compliance with DOE standards despite 80% in Aeration pump timer.

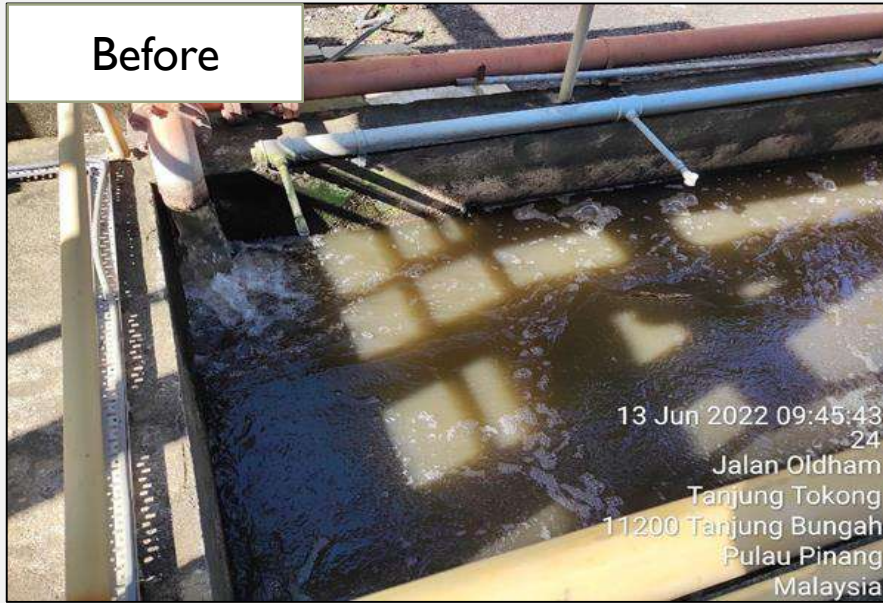
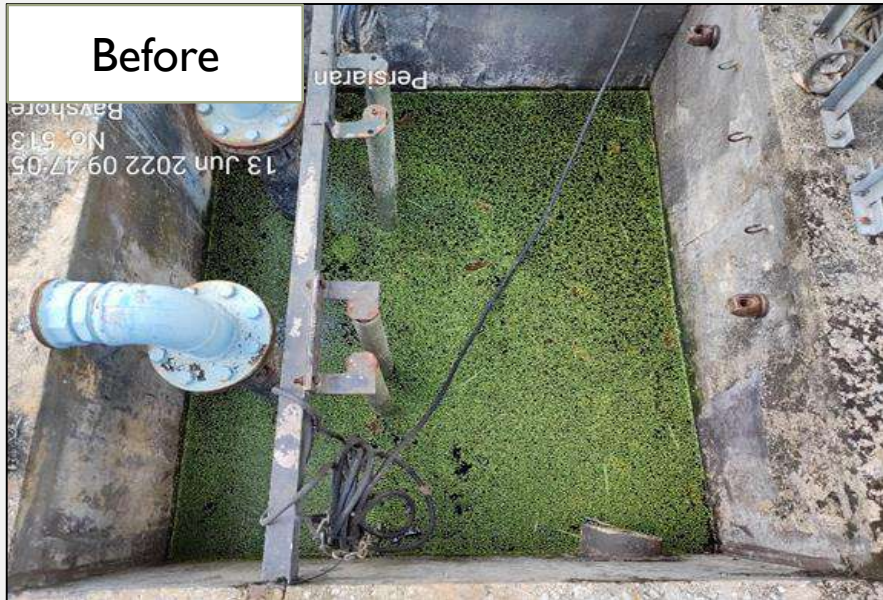
- Colour of Aeration Tank was light brown-yellowish colour with no visible floating solids.
- Minimal pungent odour near Aeration Tank.
- Aeration pump ran a total of 15 hours daily.

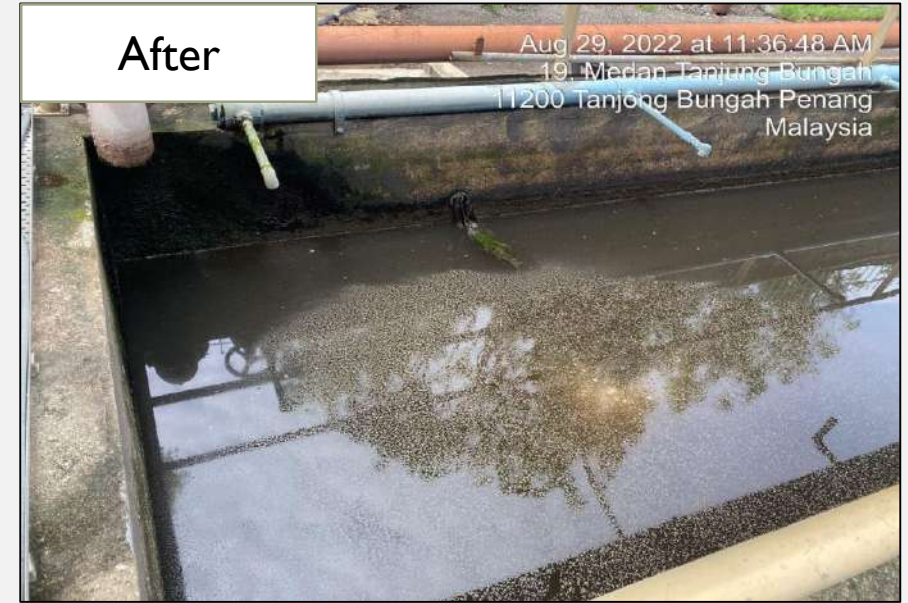
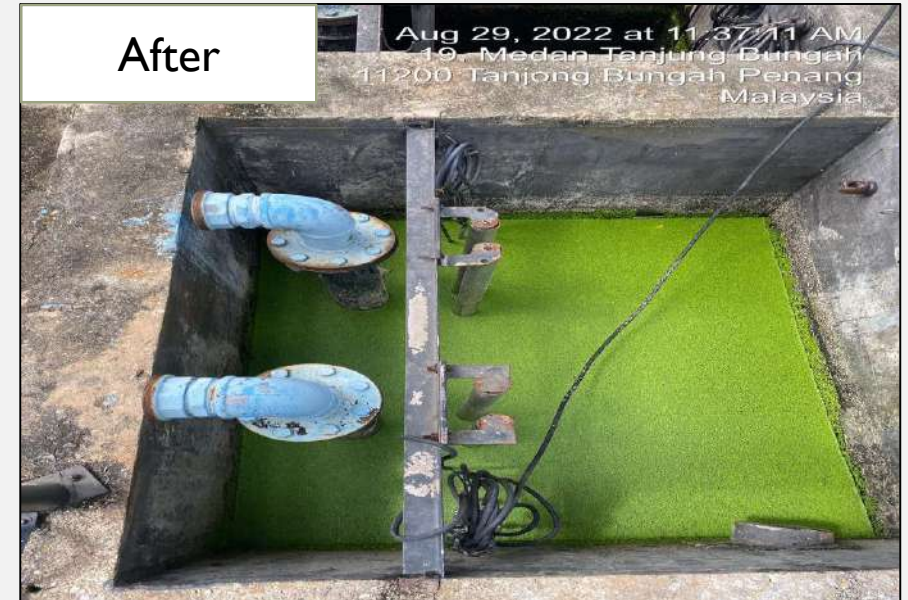
- Colour of Aeration Tank changes to a light brown-greyish colour.
- Absence of foul odour was maintained.
- Surface of Aeration Tank has become more reflective than pre-treatment conditions.
- Blooming of Duck Weed in Clarifier Tank was due to the release of trapped nutrients as a result of disintegration of activated sludge at the bottom of tank.
- Aeration pump was reduced to 3 hours daily (80% reduction).
- Final Effluent remain compliance with DOE standards despite 80% in Aeration pump timer.

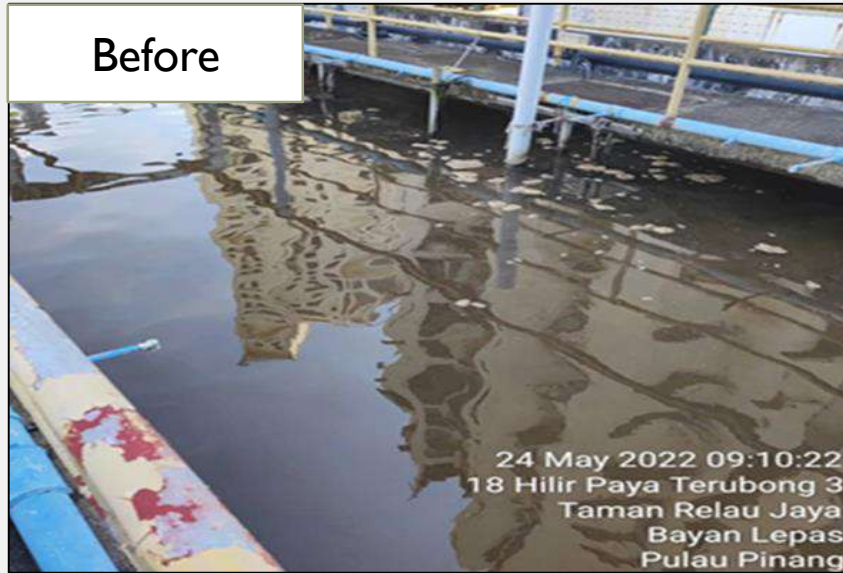
Before

Aeration & Clarifier Tank (PEG 145 – TAMAN DESA MAY)

- Colour of Aeration Tank changes to light brownish colour with a reflective surface.
- No foul odour was reported after 3 months of treatment.
- Thick hard layer of sludges from pre-treatment condition was able to be disintegrated and reduced to a clump-size floating sludges and increase in water visibility.
- Aeration pump was reduced to 4 hours daily (80% reduction).
- Final Effluent remain compliance with DOE standards despite 80% in Aeration pump timer.
