Interim Report

AquaBioSolution® Treatment for IWK STP

Duration: 1st June 2022 until 31st August 2022
Alternative solution to reduce electricity, cost of maintenance and operation of sewage treatment plant through reduction in aeration pump usage.

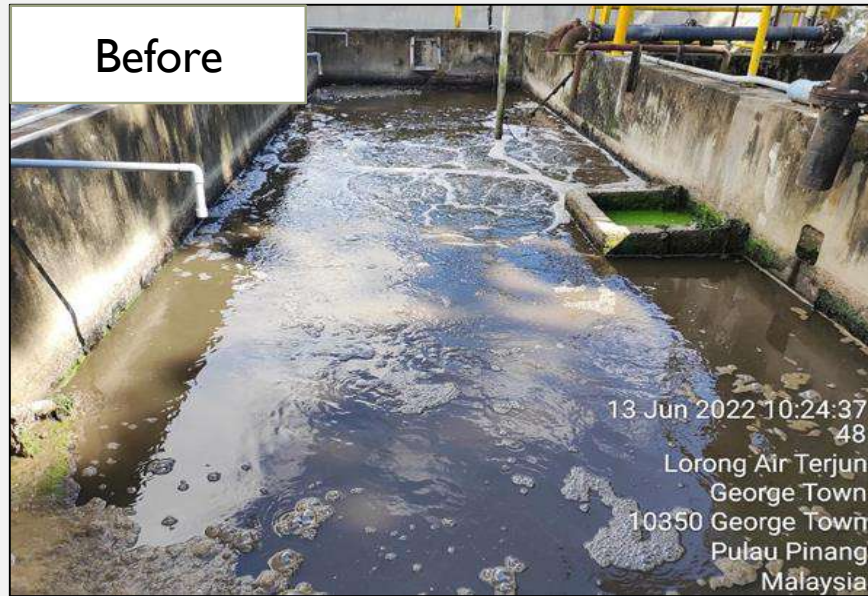
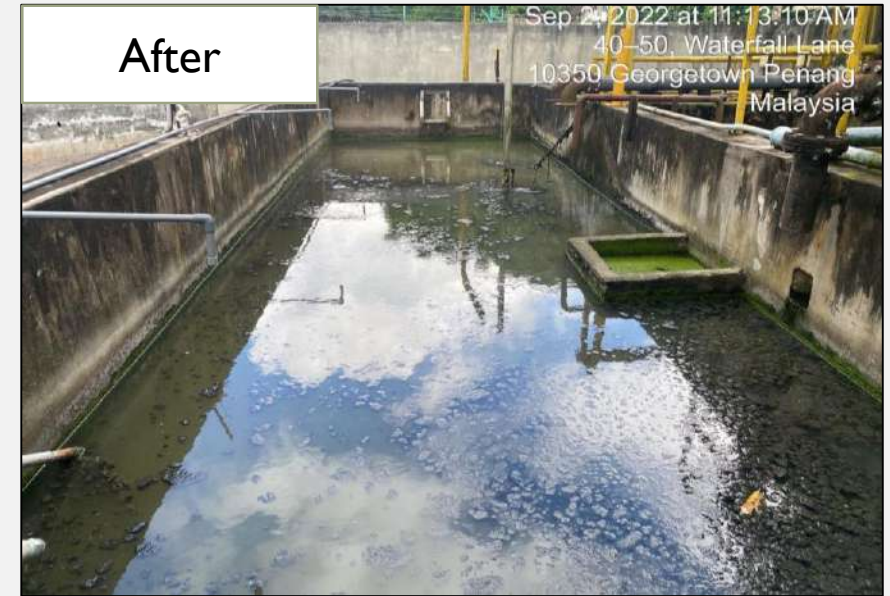
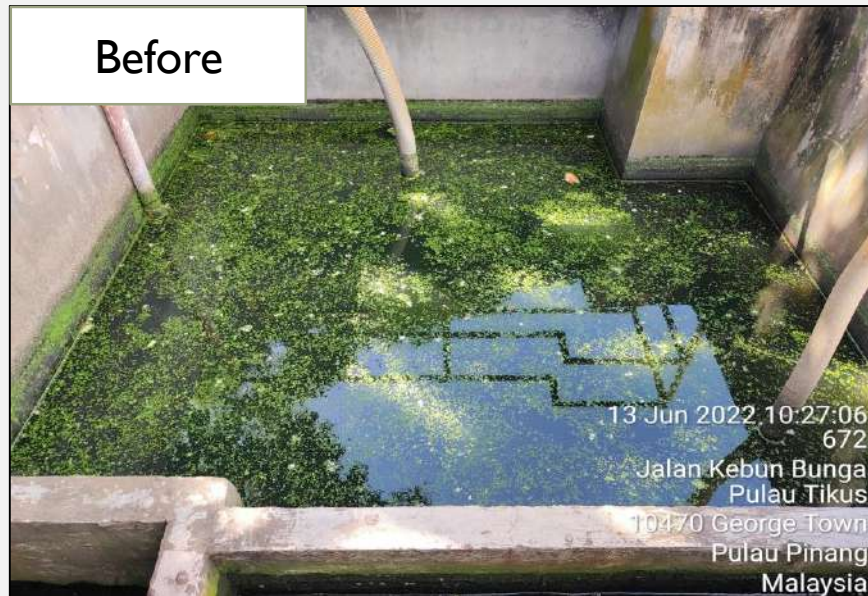
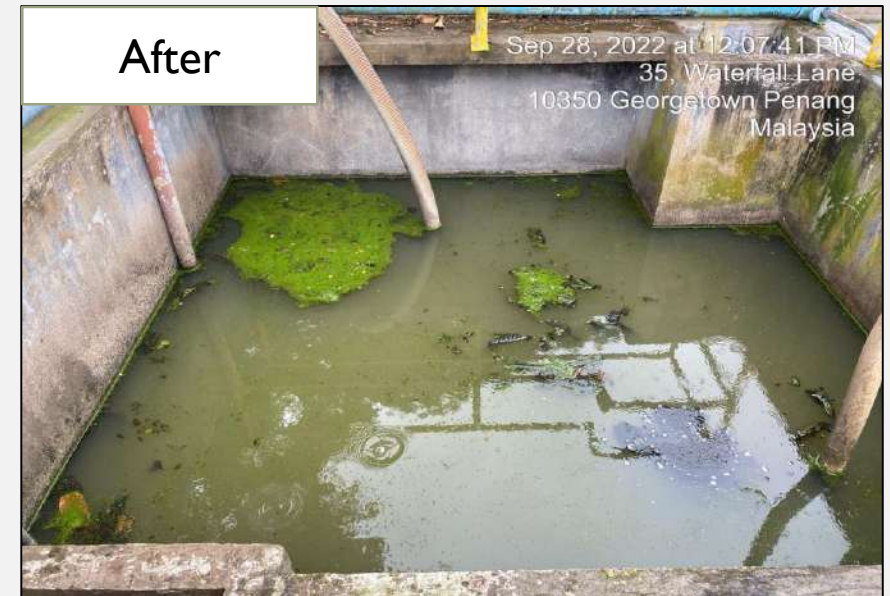
Aeration & Clarifier Tank (PEG 151 – TAMAN DESA MESRA)

- Colour of Aeration Tank was brownish colour.
- Minimal foul odour was reported at Aeration Tank.
- Significant amount of green algae film can be seen at Clarifier Tank.
- Aeration pump ran a total of 15 hours daily.

- Colour of Aeration Tank becomes brown, slightly greenish colour.
- Foul odour was successfully eliminated after 3 months of treatment.
- Green algae film bloomed on Day 60 due to the released of trapped nutrients from floor of tank, however on After, film of Green algae reduces slightly after excess nutrients has been consumed.
- Aeration pump was reduced to 3 hours daily (80% reduction).
- Final Effluent remain compliance with DOE standards despite 80% in Aeration pump timer.

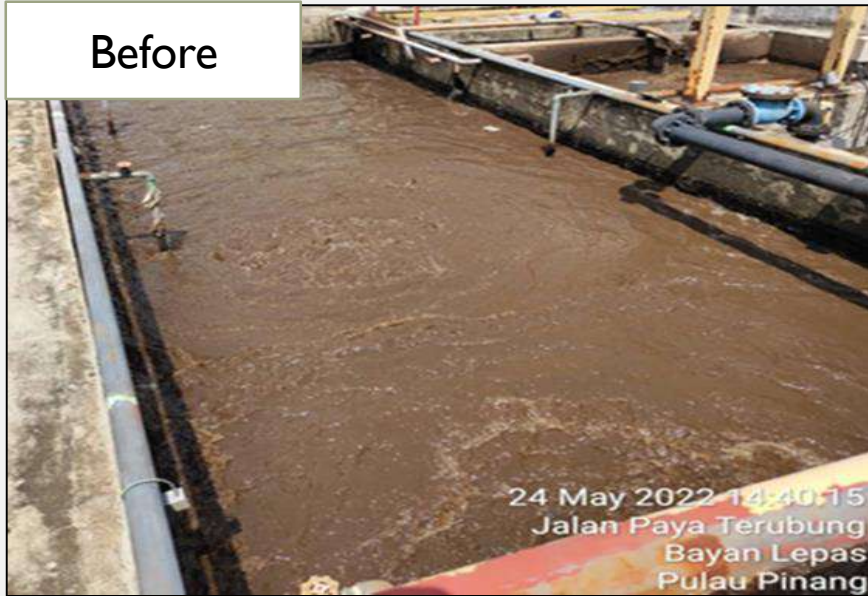
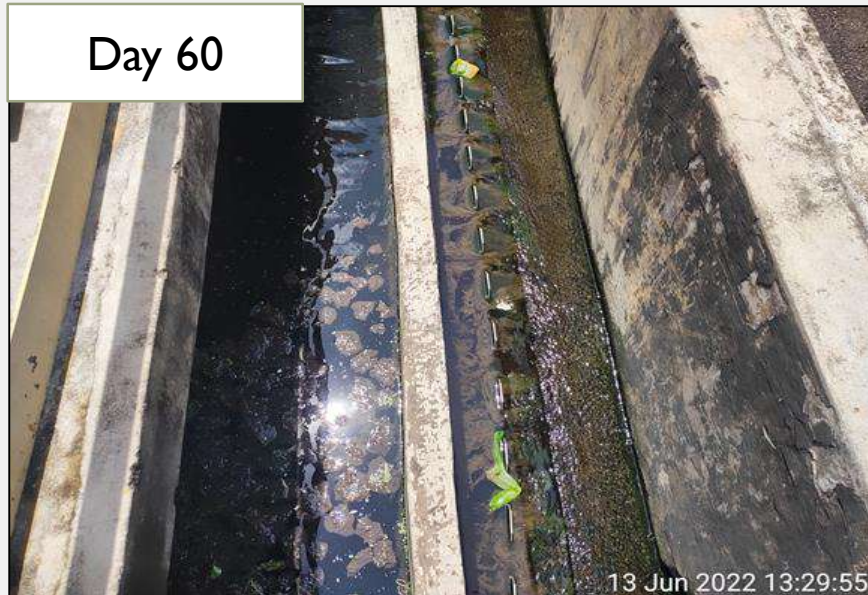
- Colour of Aeration Tank was brown, slightly reddish colour with low water clarity.
- Foul odour was minimal.
- Clumps of sludges can be seen at Clarifier Tank with a reflective water surface.
- Aeration pump ran a total of 16 hours daily.

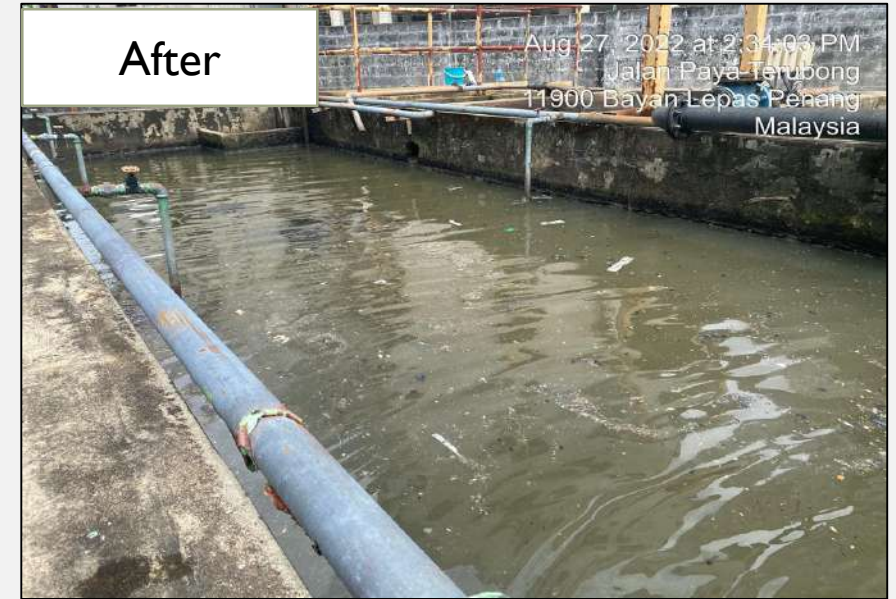
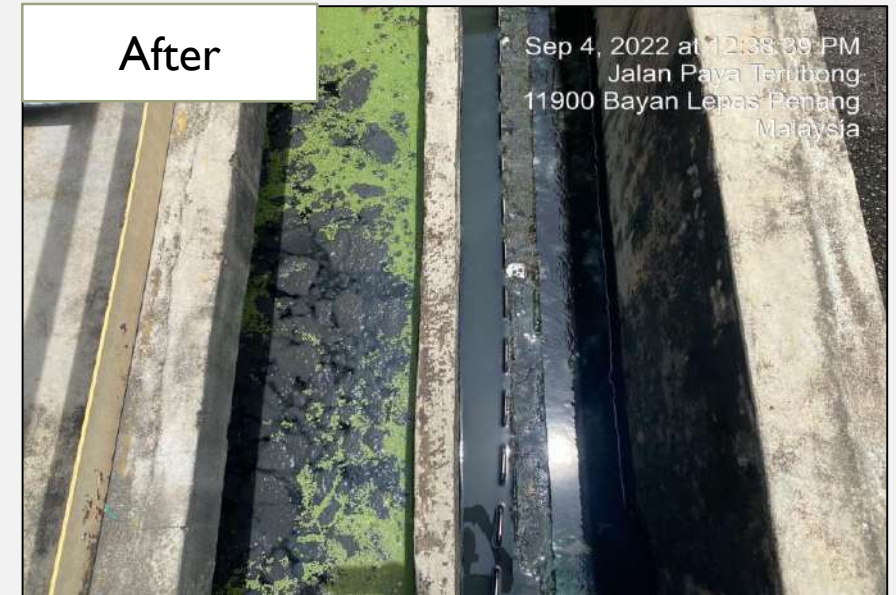
- Colour of Aeration Tank changes to a bright light green colour with a reflective water surface.
- Foul odour was able to be eliminated after 3 months of treatment.
- Clumps of sludges was able to be eliminated, but with an increase in green algae population due to the release of trapped nutrients.
- Aeration pump was reduced to 3.2 hours daily (80% reduction).
- Final Effluent remain compliance with DOE standards despite 80% in Aeration pump timer.

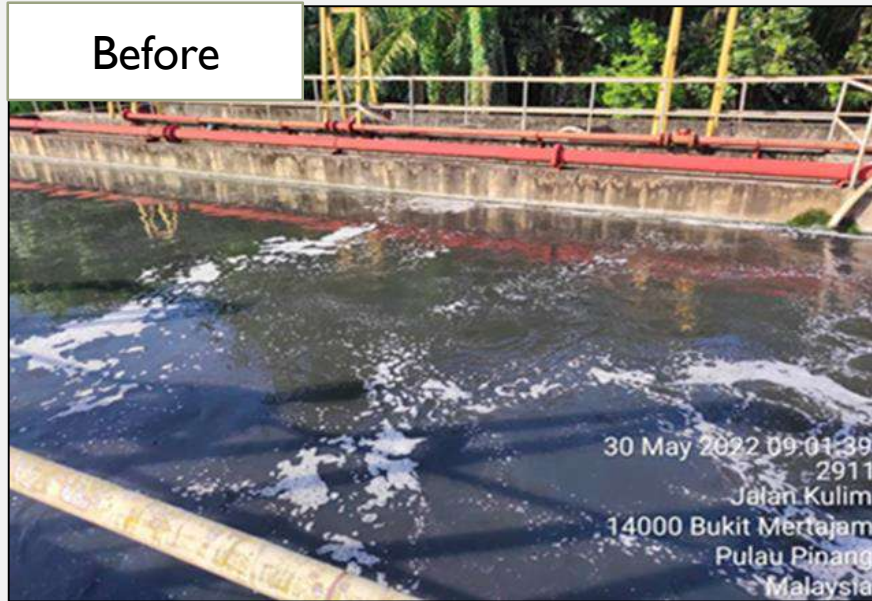
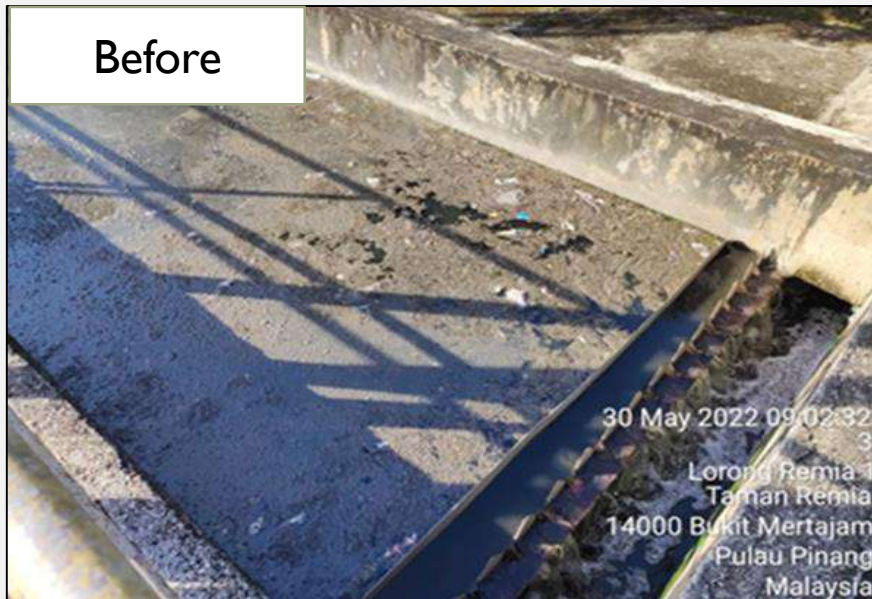
- Colour of Aeration Tank was dark grey.
- No foul odour was reported at Aeration Tank, however a strong pungent smell was detected at Final Effluent (FE) point.
- Aeration pump ran a total of 18 hours daily.

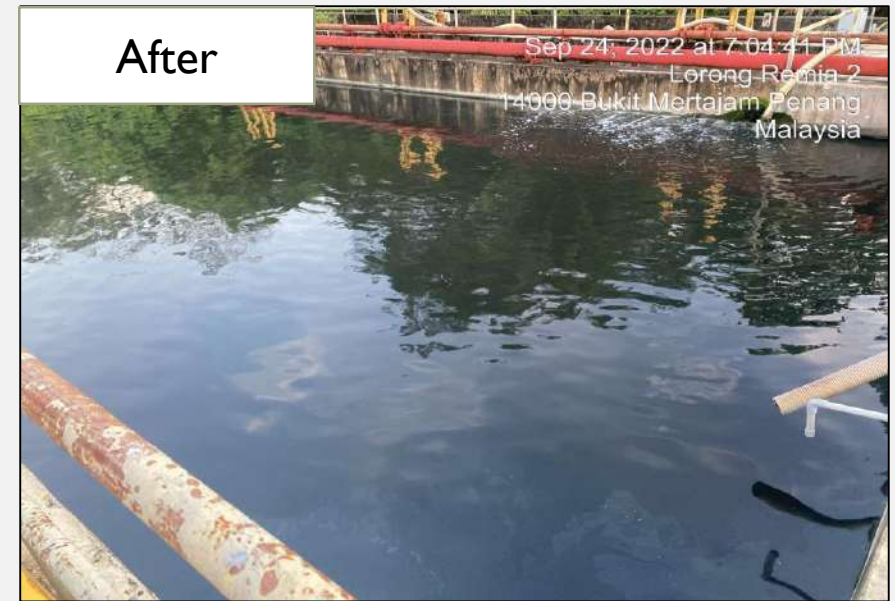
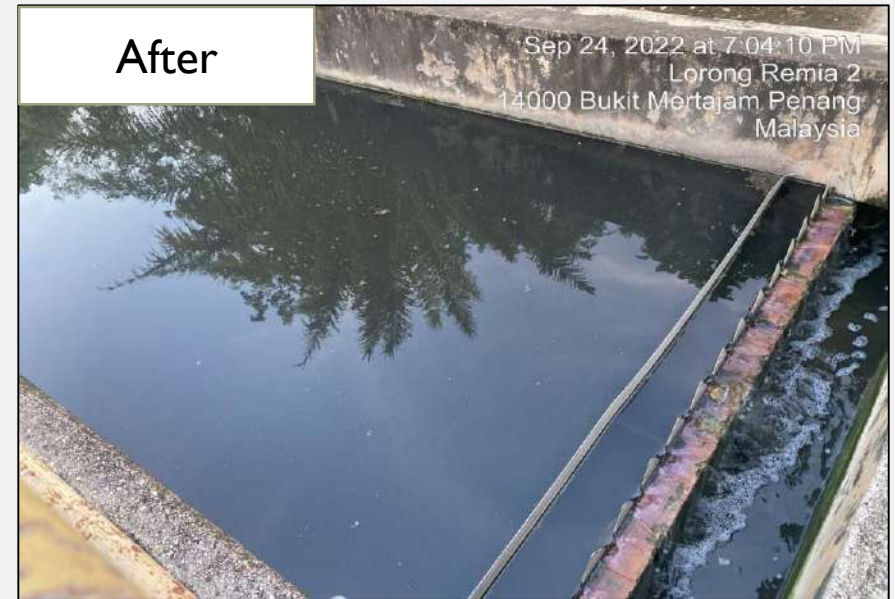
- Colour of Aeration Tank remains unchanged with the exception of reflectivity after 3 months of treatment higher.
- Absence of foul odour was maintained at Aeration Tank and significantly reduced at Final Effluent point.
- Aeration pump was reduced to 3.6 hours daily (80% reduction).
- Final Effluent remain compliance with DOE standards despite 80% in Aeration pump timer.

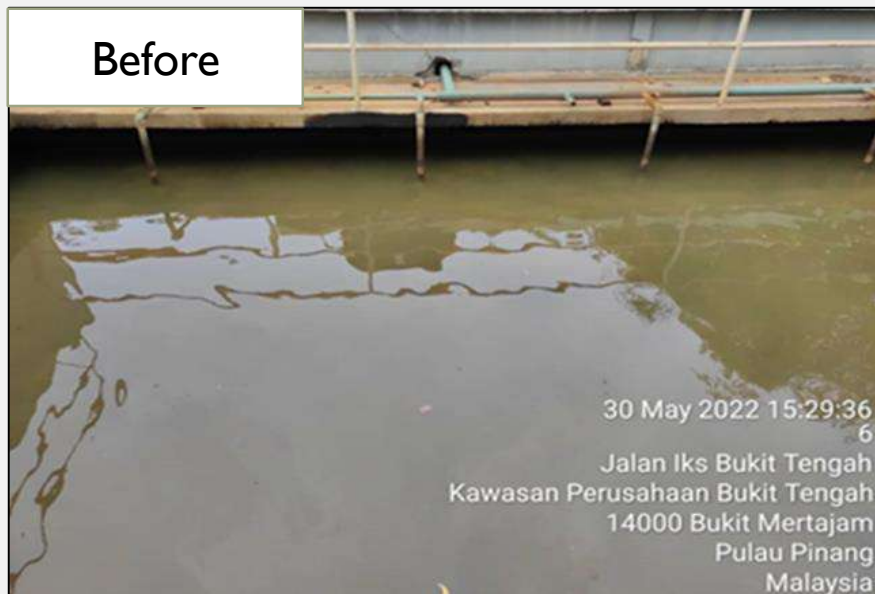
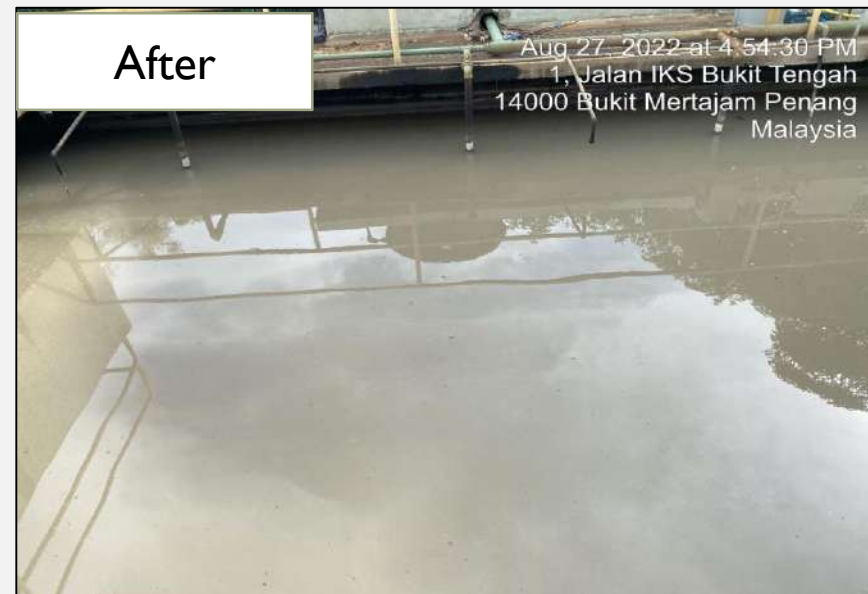
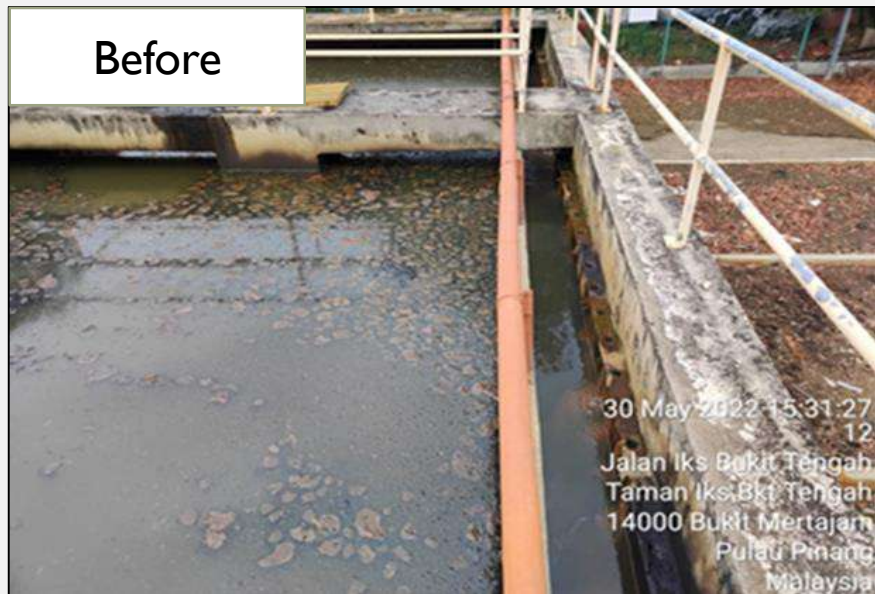
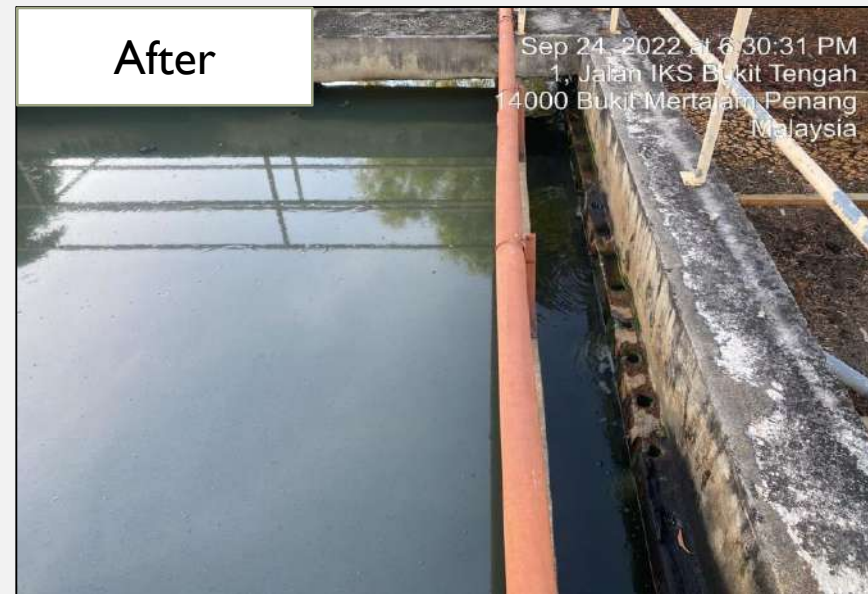
Aeration & Clarifier Tank (SPI 404 – TAMAN IKS BUKIT TENGAH)

- Colour of Aeration Tank was green-brownish with no floating solids.
- Clumps of floating sludges / oil & grease can be seen at surface of Clarifier Tank.
- Slight oil / grease smell was detected at both Aeration & Clarifier Tank.
- Aeration pump ran a total of 18 hours daily.

- Colour of Aeration Tank changes to bright grey with no floating solids.
- Oil / grease smell was able to be eliminated at both Aeration & Clarifier Tank.
- Clumps of floating solids / oil & grease was successfully eliminated after 3 months of treatment.
- Aeration pump was reduced to 3.6 hours daily (80% reduction).
- Final Effluent remain compliance with DOE standards despite 80% in Aeration pump timer.

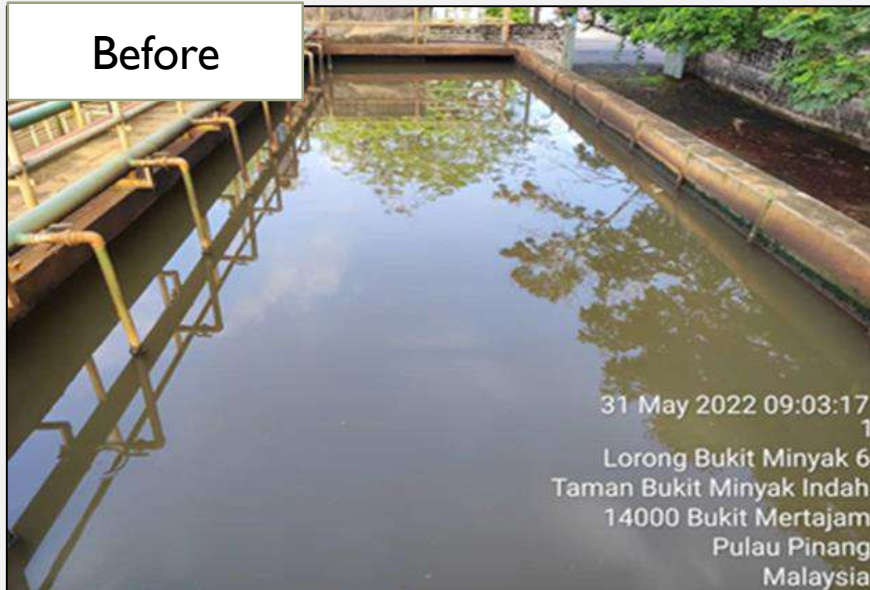
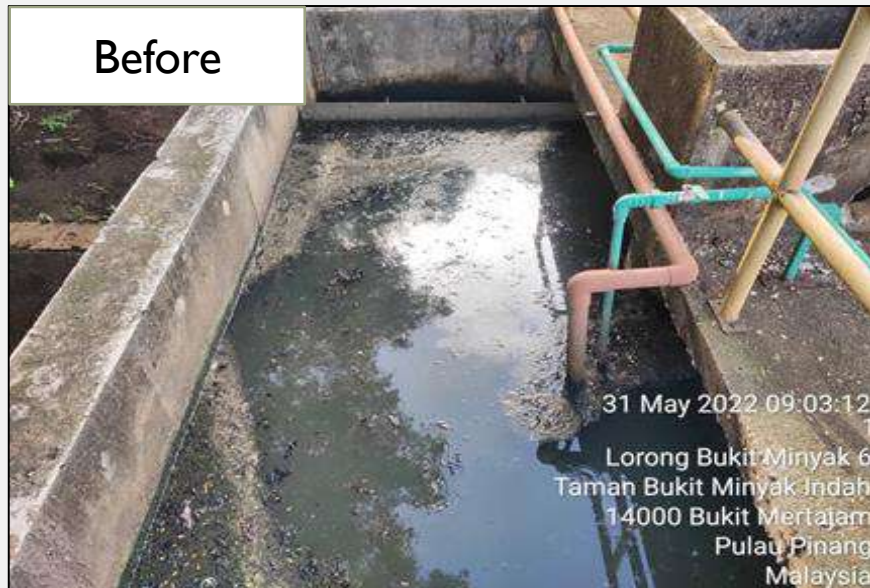
- Colour of Aeration Tank was brownish dark grey.
- Floating solids covers almost half of surface of Clarifier Tank.
- Aeration pump ran a total of 18 hours daily.

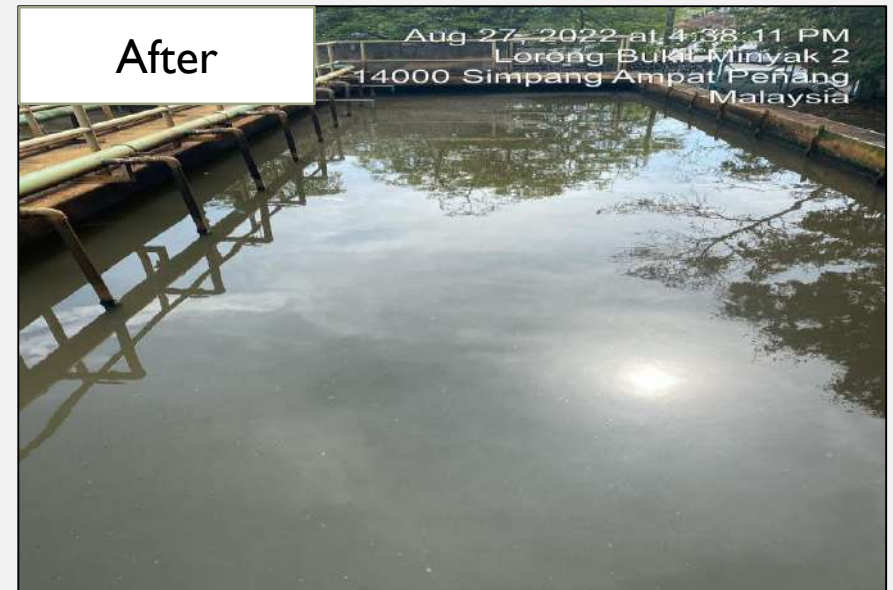
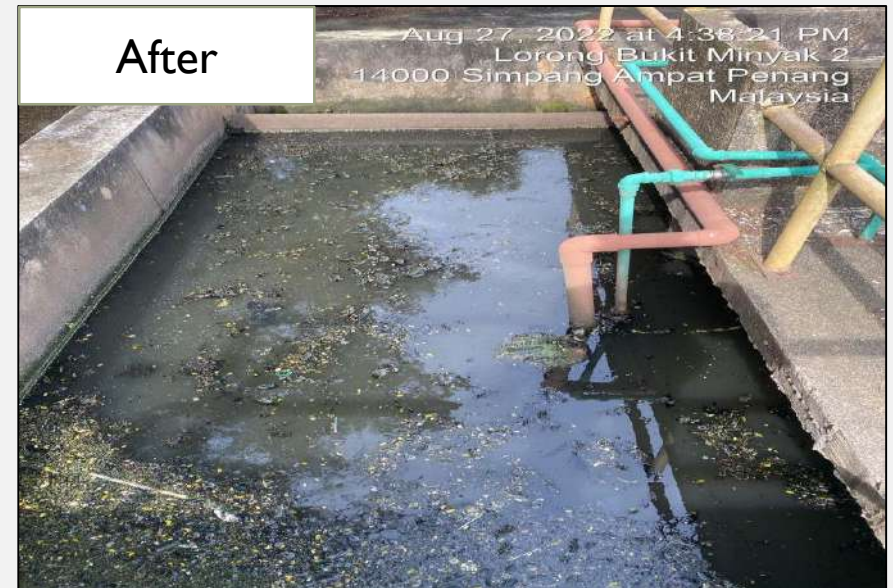
- Colour of Aeration Tank changes to greenish-grey with an increase in reflectivity of water.
- Aeration pump was reduced to 3.6 hours daily (80% reduction).
- Final Effluent remain compliance with DOE standards despite 80% in Aeration pump timer.

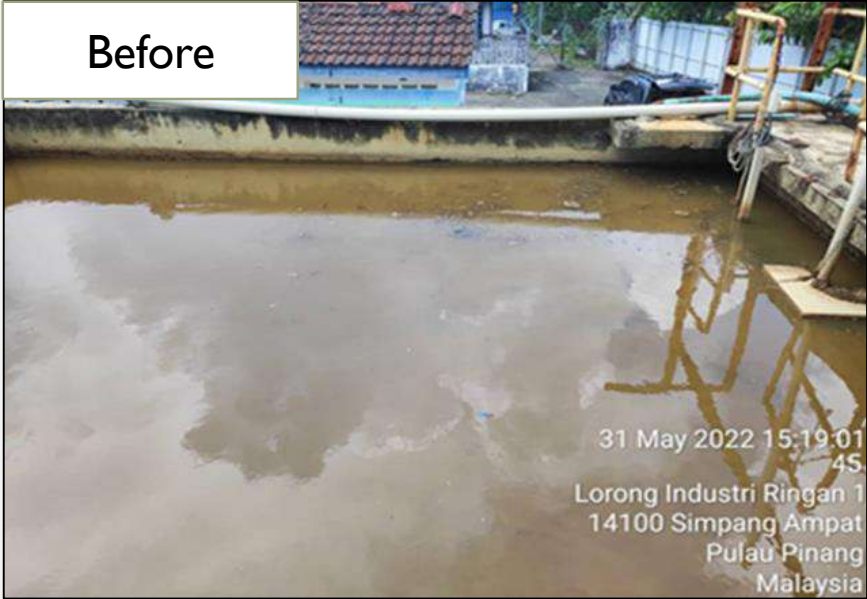
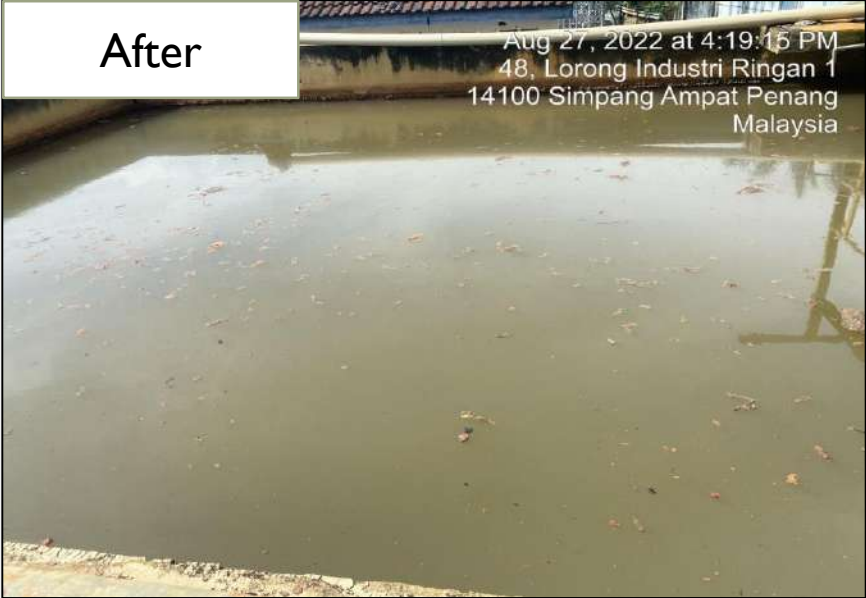
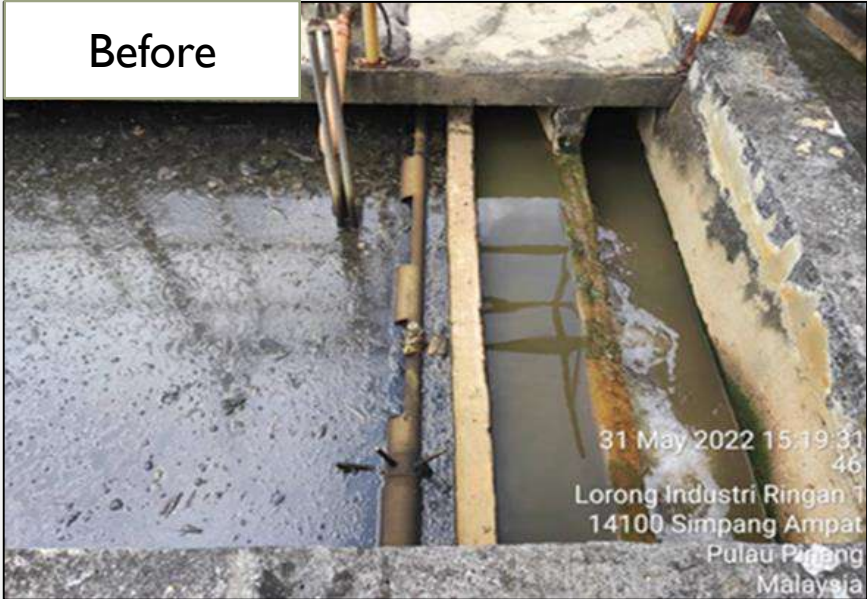
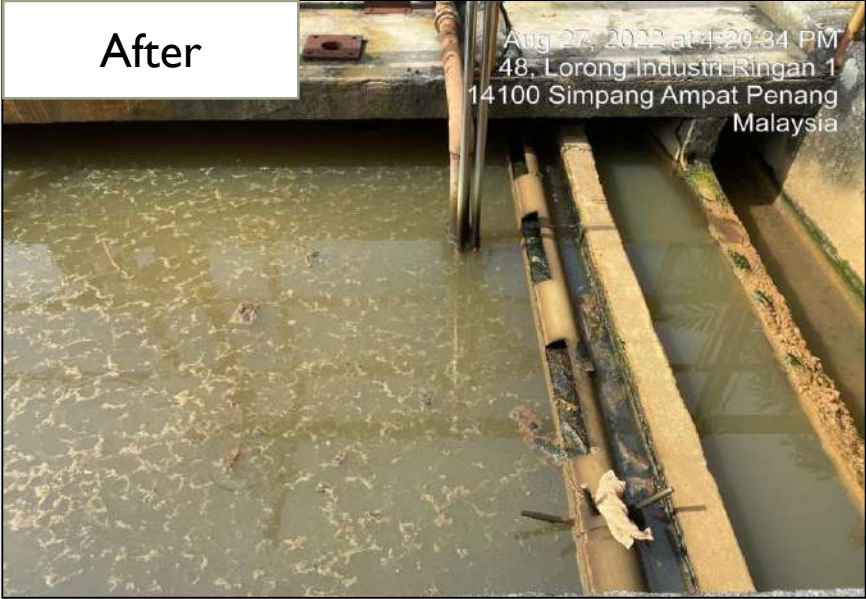
Aeration & Clarifier Tank (SPI 239 – KAW INDUSTRI RINGAN JURU)

- Colour of Aeration Tank was orange-reddish with slightly oily smell.
- Water surface of Clarifier Tank was covered with thin black film of oil & grease sludge.
- Aeration pump ran a total of 12 hours daily.

- Colour of Aeration Tank changes to a greenish-grey colour with significant reduction in oily smell.
- Film of oil & grease was successfully removed via a combination of diatom & microbial activities.
- Aeration pump was reduced to 2.4 hours daily (80% reduction).
- Final Effluent remain compliance with DOE standards despite 80% in Aeration pump timer.

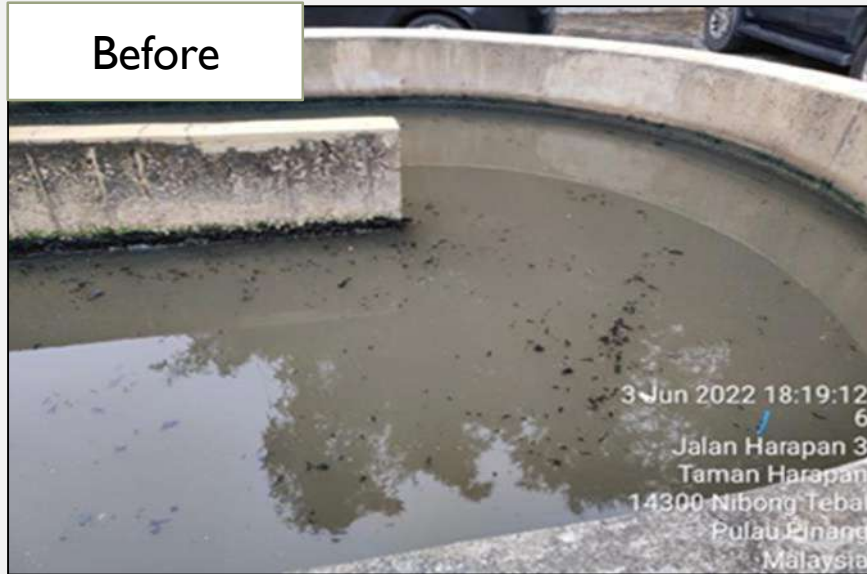
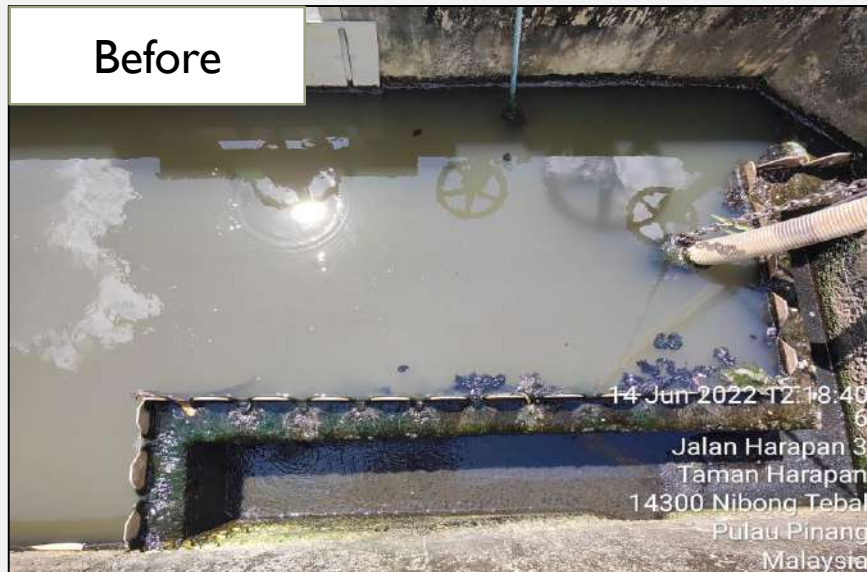
- Colour of Aeration Tank was greenish-brown colour with minimal foul odour detected.
- Small amount of floating clumped solids was observed at both Aeration and Clarifier Tank.
- Aeration pump ran a total of 14 hours daily.

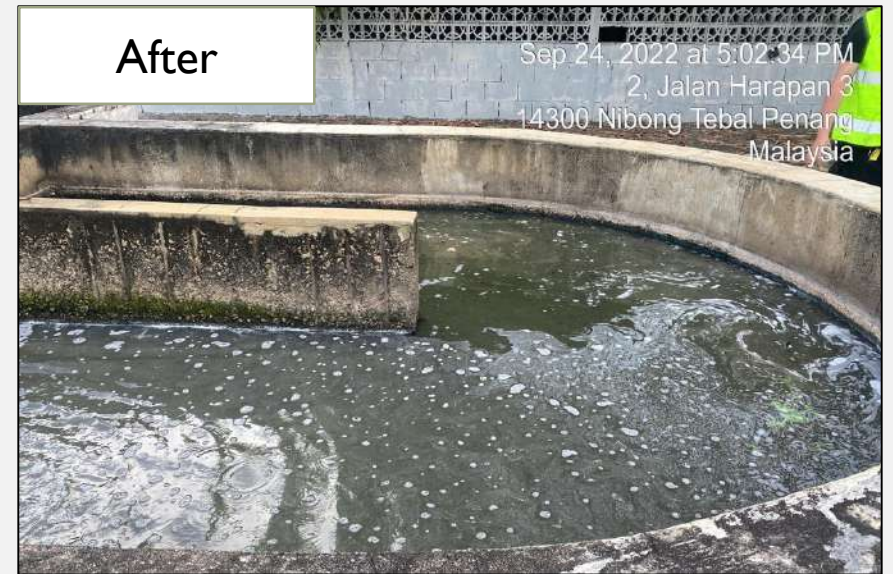
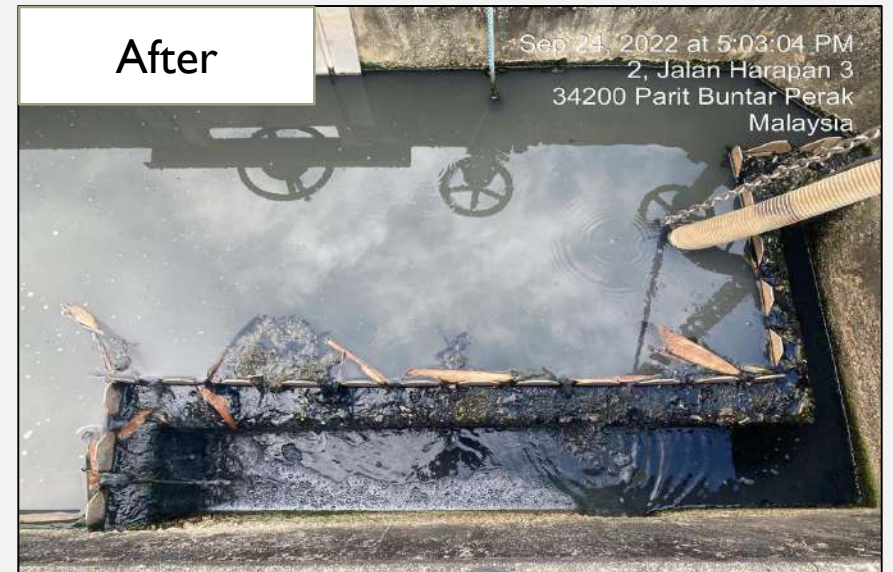
- Colour of Aeration Tank was seen to be dark in colour, however no foul odour was reported.
- Floating clumped solid was successfully removed at both Aeration and Clarifier Tank.
- Surface water of Clarifier Tank becomes more reflective after 3 months of treatment.
- Aeration pump was reduced to 2.8 hours daily (80% reduction).
- Final Effluent remain compliance with DOE standards despite 80% in Aeration pump timer.

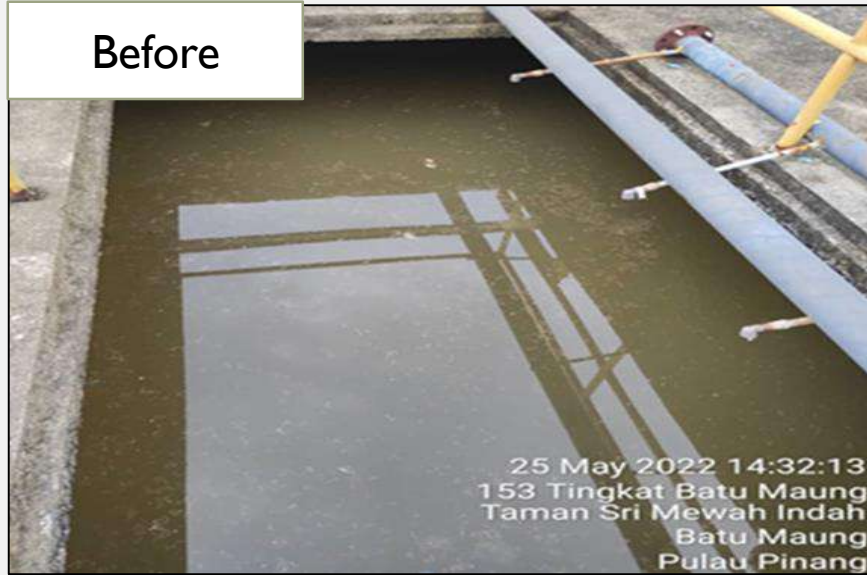
- Colour of Aeration Tank was greenish-brown colour with minimal foul odour detected.
- A number of municipal solid waste (baby diapers, plastic bags, etc) was seen at Aeration Tank.
- Clarifier Tank was seen to be covered with films of floating sludges.
- Aeration pump ran a total of 12 hours daily.

- PEG 136 is a partially enclosed aeration system, reducing sunlight penetration for Diatoms to carryout photosynthesis process to provide fine oxygens for surrounding aerobic bacteria & microbes to digest pollutants.

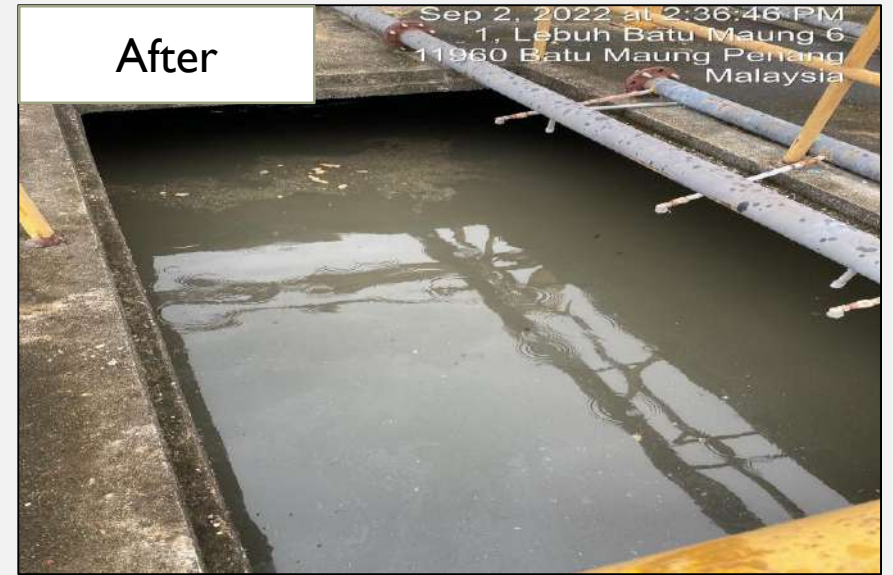
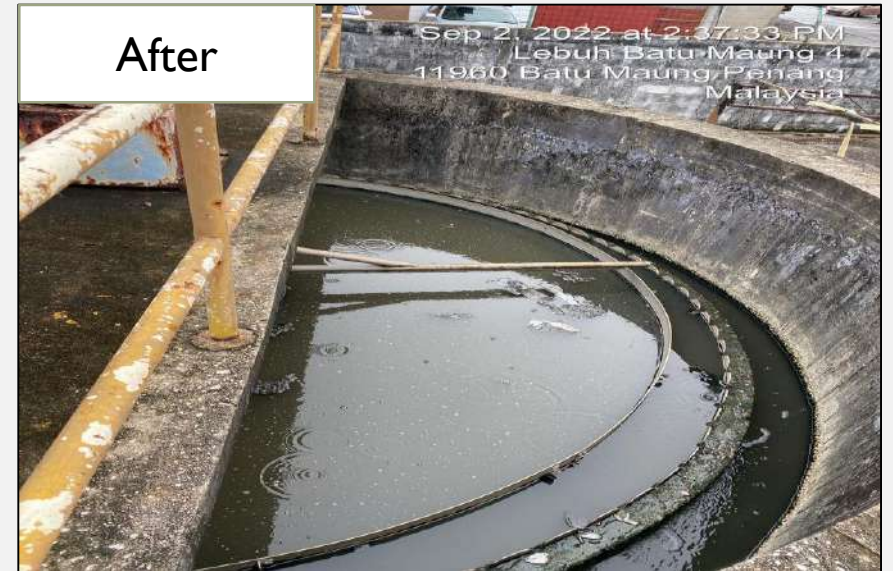
- Colour of Aeration Tank was seen to be greenish-gray in colour, minimal foul odour was still detected.
- Film of floating sludges was successfully removed at Clarifier Tank.
- Municipal solid waste was still present at Aeration Tank.
- Surface water of Clarifier Tank appears to be more reflective after 3 months of treatment.
- Aeration pump was reduced to 2.4 hours daily (80% reduction).
- Final Effluent did not comply with DOE standards with 80% in Aeration pump timer.

- ❖ However, it is to be noted that application of AquaBioSolution is ineffective against STPs with fully or partially enclosed system as it reduces photosynthesis process of Diatoms. Thus Nuaim Corporation will only accept fully opened system for future treatment projects.
